# Building Report | Life Sciences Façade & Addition

11.22.17

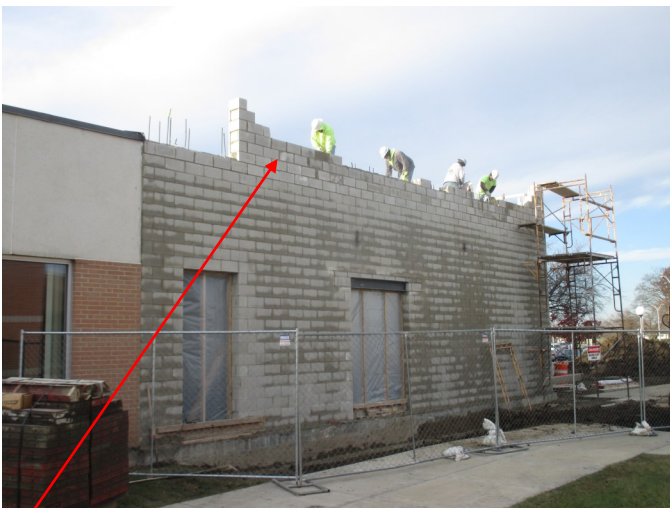
The top-left photo shows the progress of finishing the masonry shear wall on the north side of the addition. Now that the concrete roof slab is in place this work can be finished.

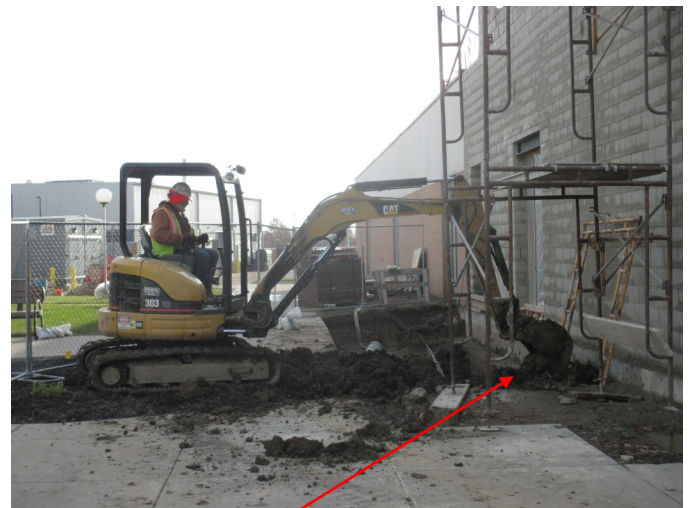
The top-right photo shows the excavation being done for the ramp and stairs that will be constructed on the north side of the addition. These ramp and stairs are necessary due to the difference in finished floor elevations between the Life Sciences Building and the neighboring Career Technology Center.

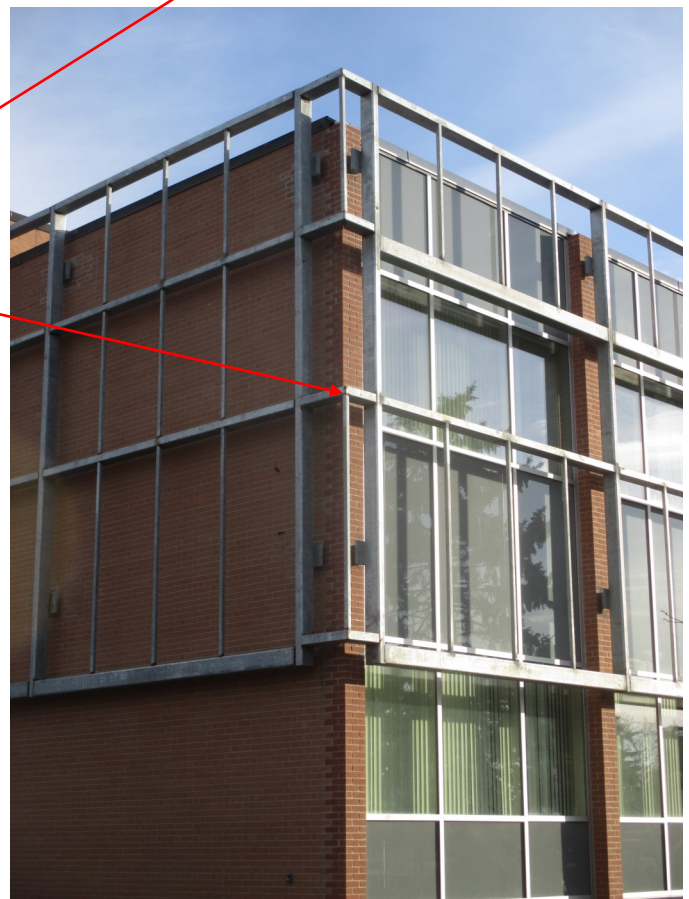
The bottom-right photo shows the final stages of the installation of the support steel for the new shade systems. The steel that will help the panels wrap the corner of the building have been installed. There a couple of delays and so the contractors will start installing the new panels next week .

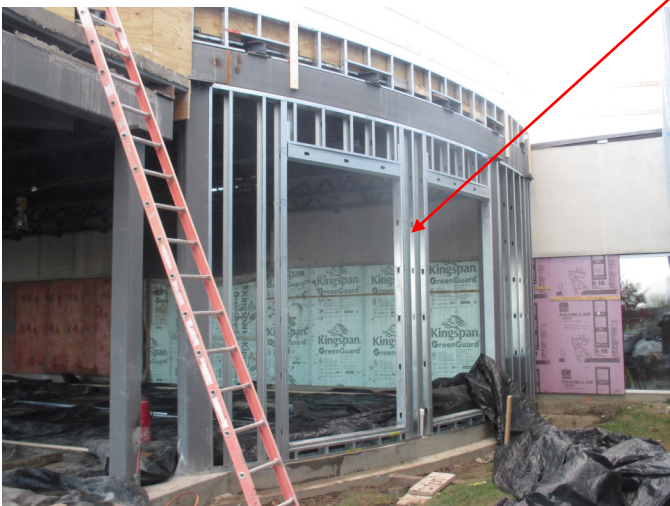
The bottom-left photo shows the light-gauge metal framing being installed for the exterior curved wall of the addition.
