# Building Report | Life Sciences Façade & Addition

9.15.17

The following are pictures from week of Sept. 11 - 15, 2017 in regards to the Life Sciences Building Façade Improvements & Addition Project. Progress is being made with the brick masons on site constructing the new brick ribs which is one of the last steps in getting the building to be weather-proofed once again after the demolition of the old brick ribs. Once all the new brick ribs are completed the steel fabricators and erectors can install the new metal sunshade systems on all four faces of the building. The foundation formwork is almost complete for the addition and the reinforcing steel cages are being assembled. Barring any bad weather the concrete for the foundation can start to be placed next week. Once the concrete for the foundation is cured enough the metal framing for the exterior walls of the addition can be installed.

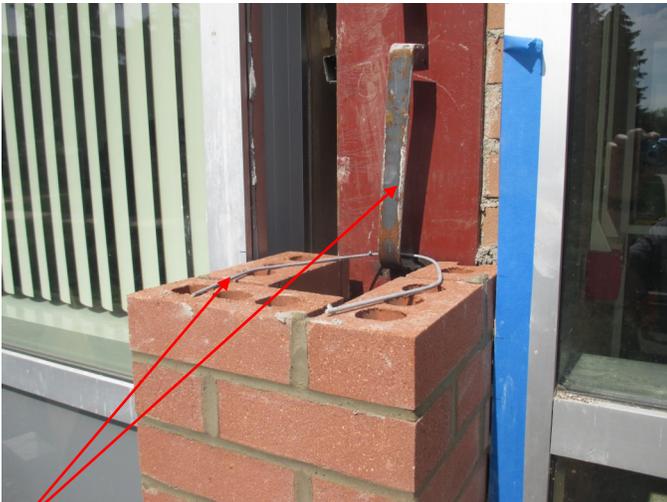
The top-left photo shows a detail of the new brick ribs that are going up between the existing sections of curtain wall systems. Here you can see a new stirrup-shaped horizontal tie hooked into an existing slotted anchor connected to the building frame. This tie anchors the brick piers to the building, and the slotted anchor allows for the materials to expand and contract at different rates to avoid cracking.

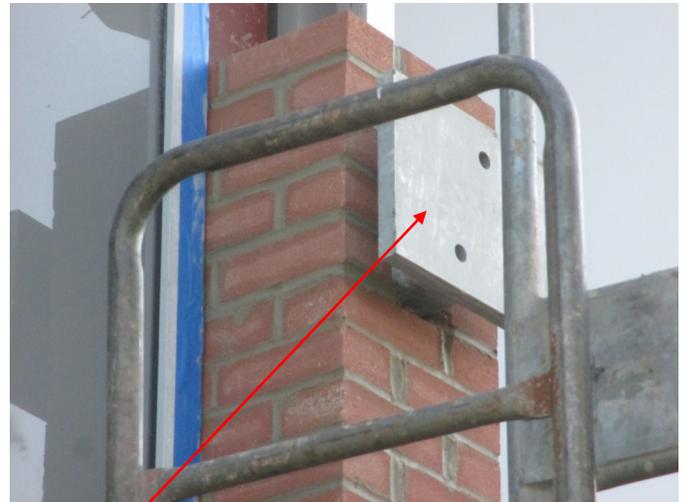
The top-right photo shows some of the new brick work around the new anchor plates for the new metal sunshade system to be installed later.

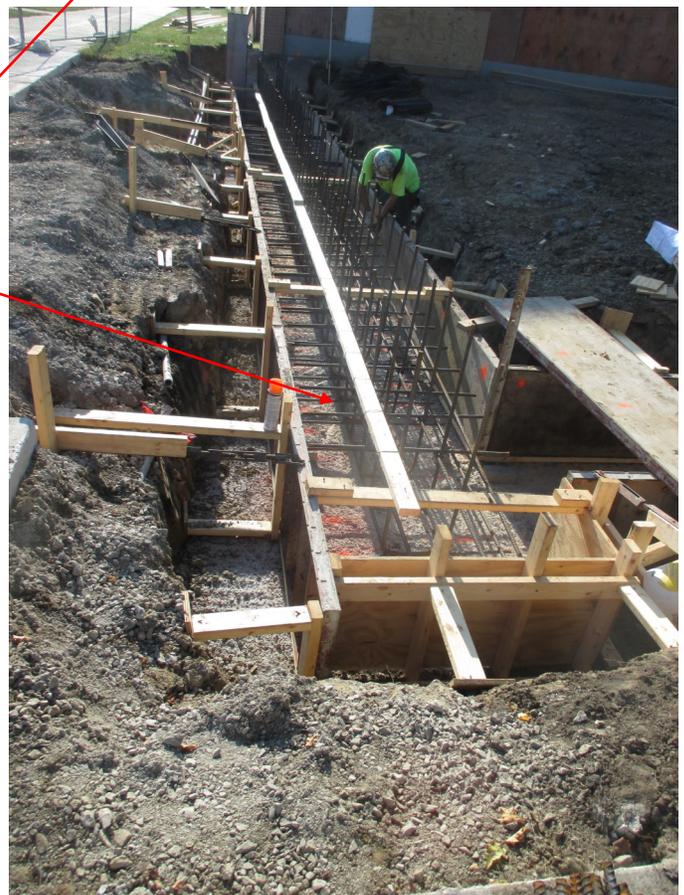
The bottom-right photo shows the progress of the assembling of the reinforcing steel as it is being placed in the forms for the foundations for the addition. Once placed the concrete will cure around the steel and provide a solid foundation for the building addition framing.

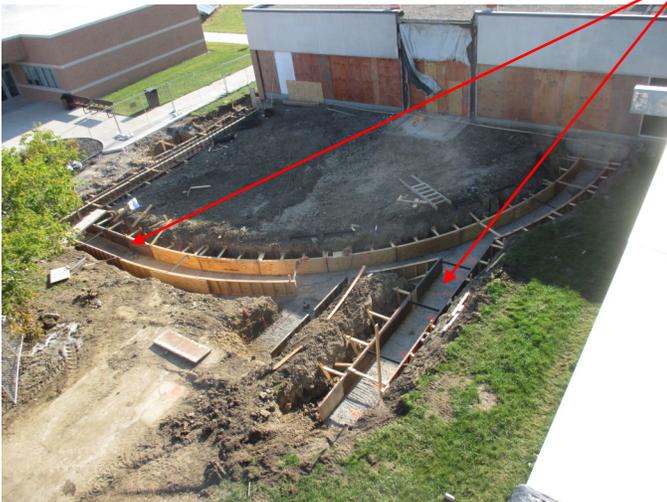
The bottom-left provides a good overall look at the new addition being constructed. The out line of the addition is becoming easier to identify, and provides a better sense of scale.
