**MONROE COUNTY COMMUNITY COLLEGE  
FACILITIES ASSESSMENT AND DEFERRED MAINTENANCE  
CAPITAL PLANNING REPORT  
2011 UPDATE**

**SHWGROUP**  
ARCHITECTS | ENGINEERS | PLANNERS

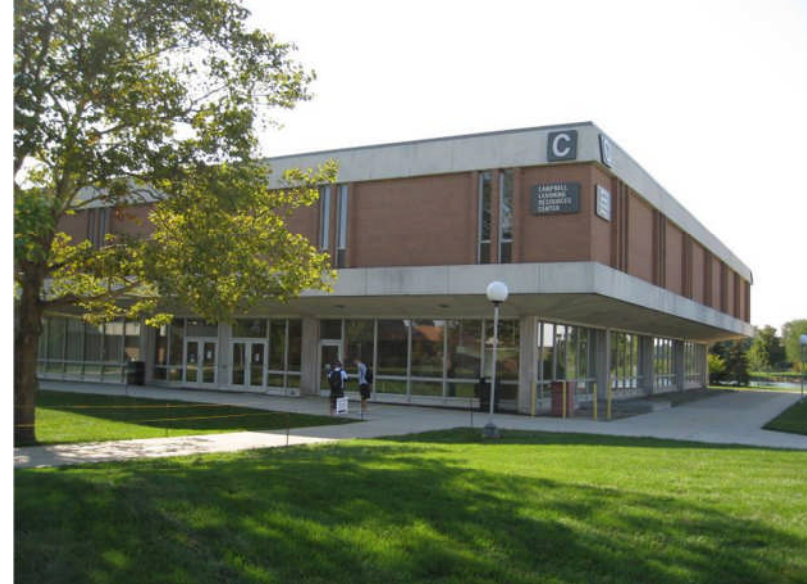
- Minor cracking observed in brick walls at main stairwell. Recommend monitoring condition.
- Original exterior aluminum doors, frames, and hardware are nearing end of life.

- Stairwell doors are in poor condition and at end of life.
- Rear double doors at Learning Assistance Lab - hinges damaged, doors stick, doors swing into corridor.

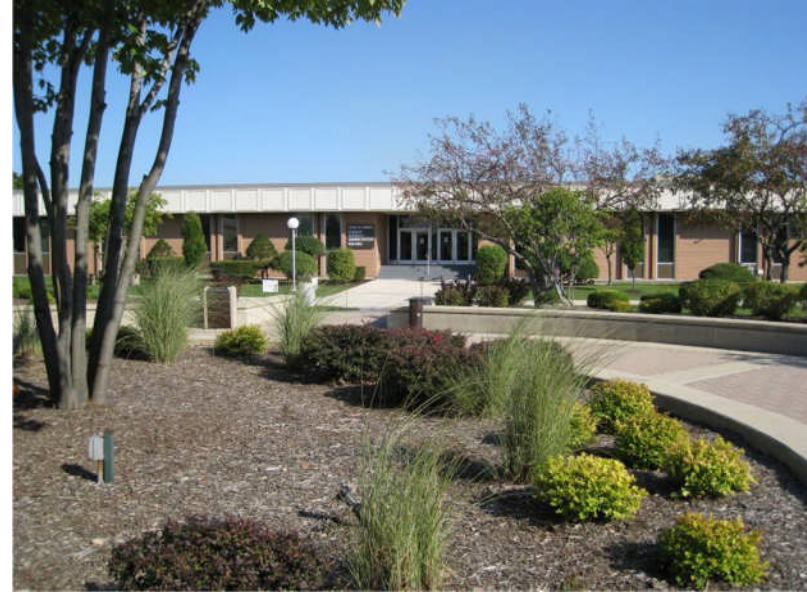
- Original exterior aluminum doors, frames, and hardware are nearing end of life.
- East entry concrete steps poorly constructed - risers vary in height, treads are too shallow and uneven. Creates tripping hazard.

- Glass covered walkway between this and East Technology Building leaks in multiple locations. Repaired repeatedly, but steel rusting, paint peeling.

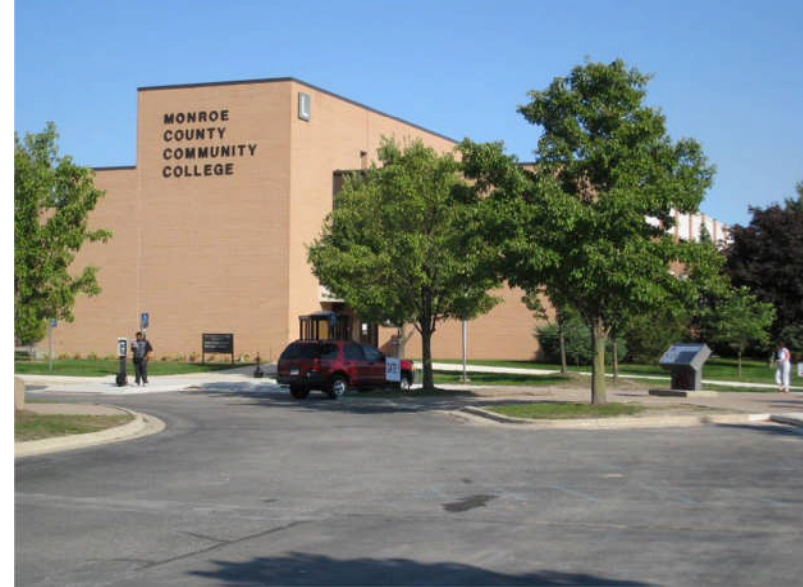
- Wireless equipment is at end of life and requires replacement.
- Interior door hardware at end of life and due for replacement. Approximately 50% of door knobs replaced with lever handles.

- Office carpet at end of life and due for replacement.

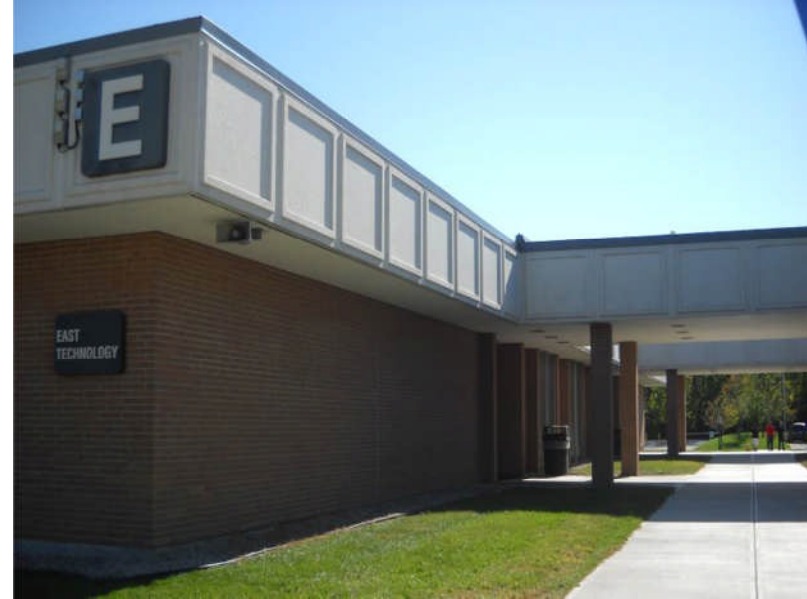
- PSI rates the roof condition as “generally in fair to poor condition.” No leaks reported. Minor roof repairs done in 2010.
- Previous roof leak at room E-125, partially repaired in 2008 and may need additional work.
- Two-part, non-insulated glazing is typical throughout with no reported problems. Weather stripping is failing and requires ongoing maintenance. Windows are nearing end of life.
- Sealant joints at fascia panel joints were replaced in 2010.
- Reheat control valves, isolation valves, and thermostats are at end of life and are due for replacement
- Domestic hot water lines are fouled and near end of life. Domestic water piping needs epoxy lining or replacement.
- Wireless equipment is at end of life and requires replacement.
- Exterior doors remain in poor condition, hardware worn, all at end of life and due for replacement.
- East Vestibule not ADA compliant; too shallow.

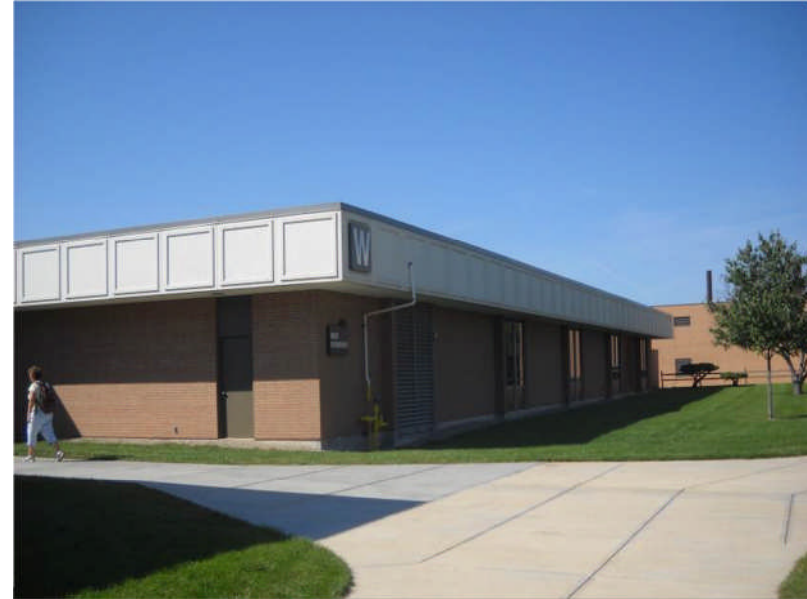
- Cracking was observed in a corridor wall within Room 164. The cause of the cracking is unknown. Recommend annual monitoring.
- Original exterior aluminum doors remain in poor condition, hardware worn, all at end of life and due for replacement.

- East Vestibule not ADA compliant; too shallow.
- Floor in Room 164 is cracked, damaged, and due for replacement.

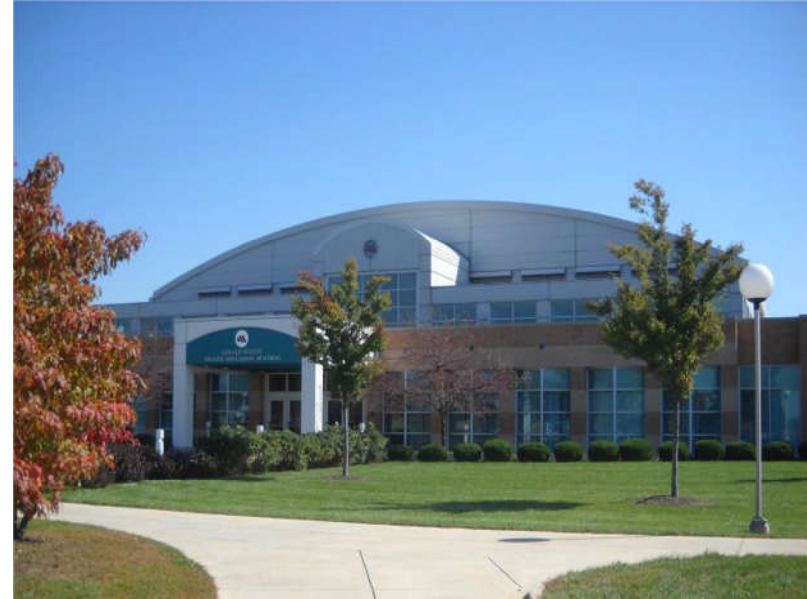
- Two gas-fired, low pressure, steam boilers (Weil-McLain).
- Noise problems with gymnasium air handling unit, system cannot run at high speed when noise is a concern, causing space to be too hot.

- Daylighting control of the Atrium fluorescent fixtures should be considered for energy savings.
- Wireless equipment is at end of life and requires replacement.

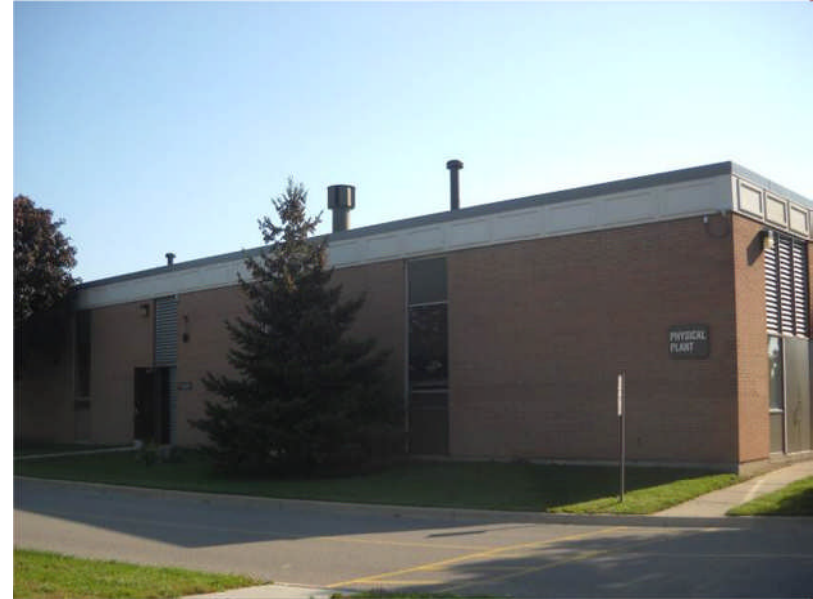
- Incidental cracking noted within CMU walls at a number of locations including the director's office. Cracking appears to be stabilized but should be monitored.
- PSI rates the roof condition as "generally in fair condition, no roof leaks were reported." Minor roof repairs done in 2010.
- Minimal glazing, original single pane, nearing end of life.
- Sealant joints at pre-cast concrete panel joints at end of life; due for replacement.
- Absorption Chiller - Cooling Tower and tank: nearing end of life and will require replacement.
- Building houses utility tie-in and is the 13,200V distribution source for the campus. No problems were reported.
- Wireless equipment is at end of life and requires replacement.
- Office space and toilet room not ADA compliant.
- Fire alarm is pull station only (no detection).

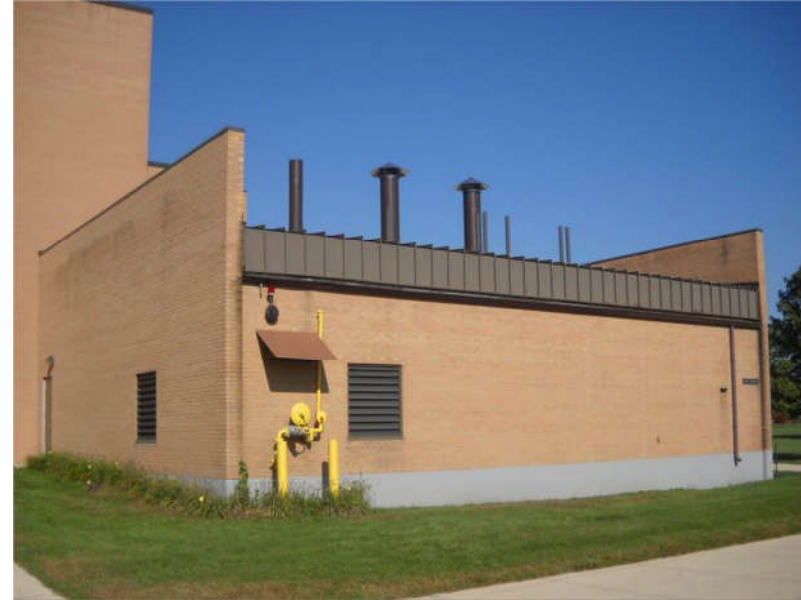
- Original standing seam metal roof is regularly inspected and has no reported problems. PSI rates the roof condition as “generally in fair condition.”
- Sealant joints for building at end of life.
- Two original, gas-fired, low pressure, Cleaver-Brooks steam boilers (1978-1979). Boilers are annually inspected and maintained: Fire tubes show pitting on exterior. College anticipates full boiler replacement by 2020.
- Galvanized piping failing, main lines replaced. Balance of piping requires replacement of long sections when failure occurs. Entire piping system due for replacement.
- Two hot water tanks (one installed in 2007 and one in 2010).
- Fire alarm is pull station only (no detection).

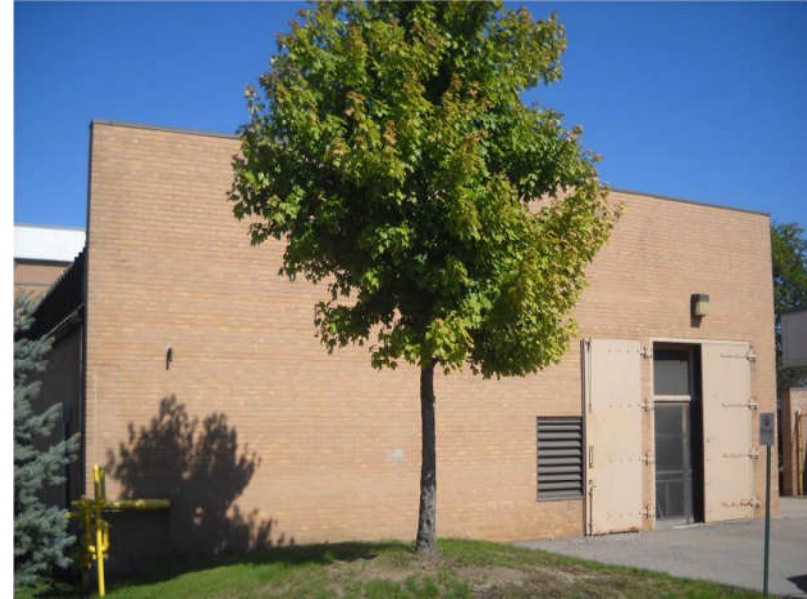
- Original standing seam metal roof. Roof is regularly inspected and has no reported problems. PSI rates the roof condition as “generally in fair condition.”
- Two original, gas-fired, low pressure, Cleaver-Brooks steam boilers (1978-1979). Boilers are annually inspected and maintained: Fire tubes show pitting on exterior. College anticipates full replacement by 2020.
- Two hot water tanks; one replaced in 2004 and a second tank added in 2005.
- Large double door (original) is rusting and requires cleaning and repainting.
- Fire alarm is pull station only (no detection).

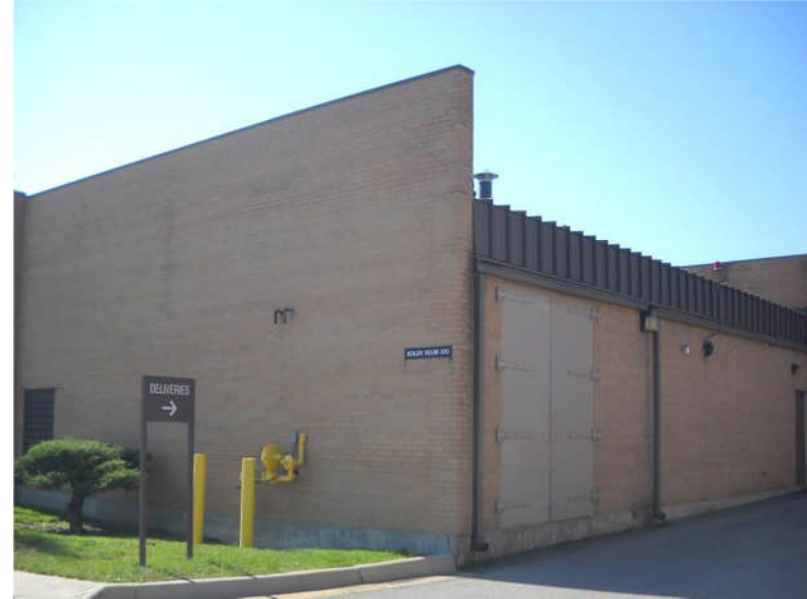
- Original standing seam metal roof is regularly inspected and has no reported problems. PSI rates the roof condition as “generally in fair to poor condition.” Minor leaks reported.
- Two original, gas-fired, low pressure, Cleaver-Brooks steam boilers (1978-1979). College anticipates full replacement by 2020.
- Galvanized piping failing, requires replacement of long sections when failure occurs. Entire piping system due for replacement.
- Two hot water tanks - 1 replaced in 1999, the other replaced in 2002. New hot water tank added for kitchen in 2002.
- Large double door (original) is rusting and requires cleaning and repainting.
- Fire alarm is pull station only (no detection).

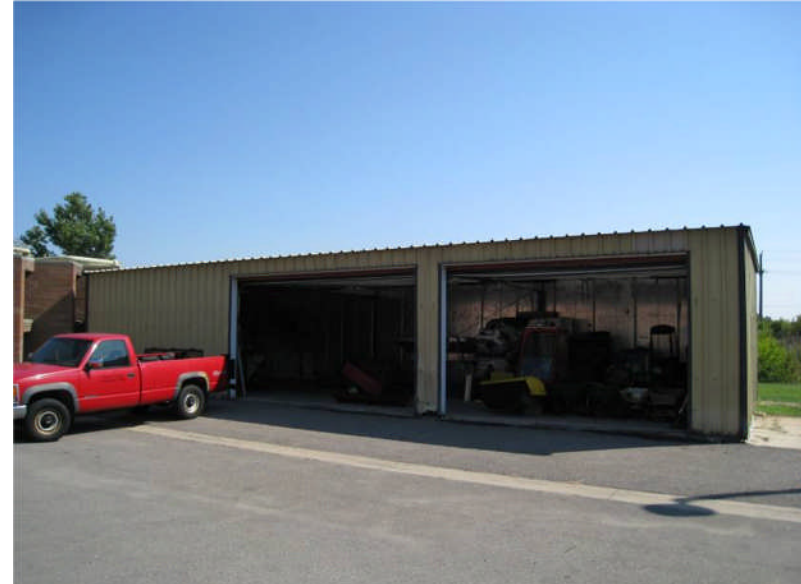
- Metal siding has cosmetic damage from vehicle / equipment impacts. The resulting damage will allow water to enter the building. Condition should be corrected.

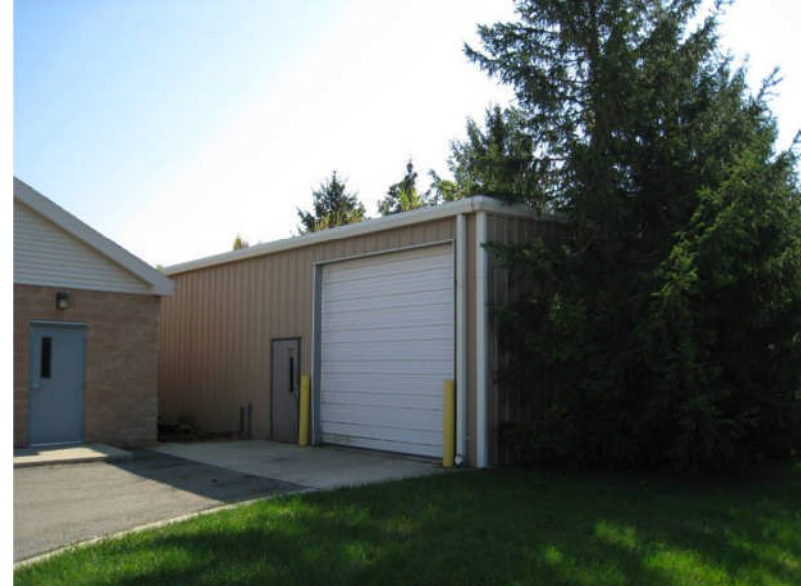
- Corrugated metal roofing panels and wall panels with exposed, gasketed fasteners. Roof regularly inspected; can see daylight in some locations. Corrugated metal siding panels appear to have original, factory finish; nearing end of life.
- Gutters were full of debris and non-functional. Correct gutter condition and replace and/or repair missing downspouts.
- Aluminum-framed window, exterior screen assemblies are in need of repair.
- Natural gas line installed from SAE Building to the Technology Building was run above grade and is protected from damage by a large steel pipe. This installation is not code compliant and needs remediation.

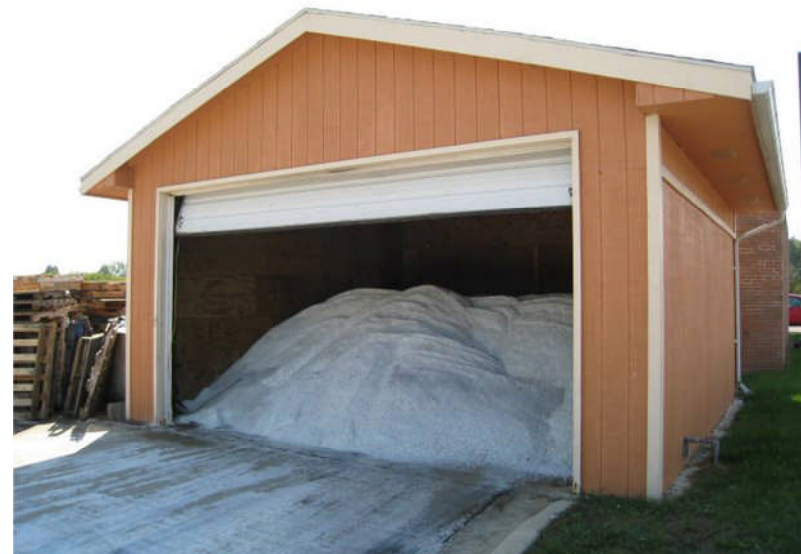
- Salt has pushed the rear wall of the building out of plane. Currently the wall is restrained using a series of wooden braces. Wall should be restored to plumb and level condition once the salt supply is emptied.
- No reported roofing problems. Roof evaluation was not included in PSI's roofing condition report. No visual defects were noted.
- Overhead door tracks and associated door hardware are failing due to the corrosive nature of the salt and are nearing end of useful life.
- No visual inspection of floor surface was possible.

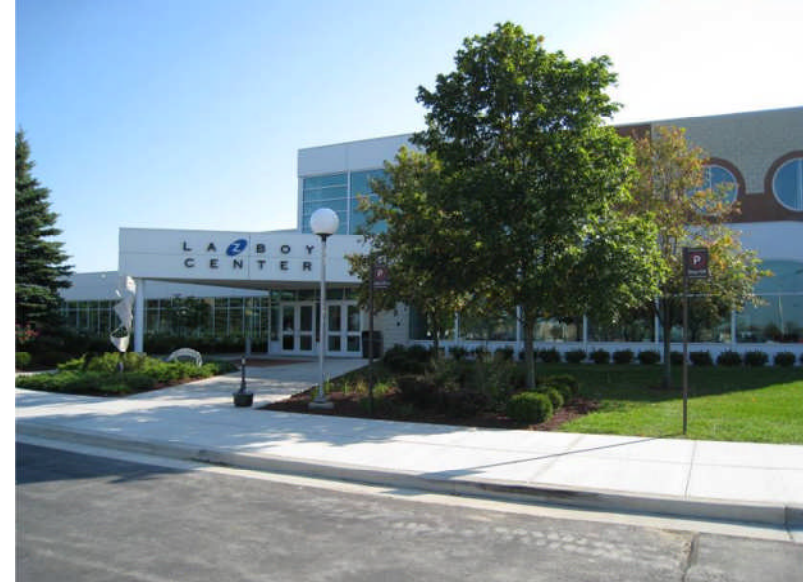
- IT Room H143 needs a door grille added to provide proper ventilation.
- Wireless equipment is at end of life and requires replacement.
- Two, gas-fired, low pressure, Weil McLain heating hot water boilers (installed in 2004).

- One gas-fired, atmospheric, domestic hot water tank (installed in 2004).

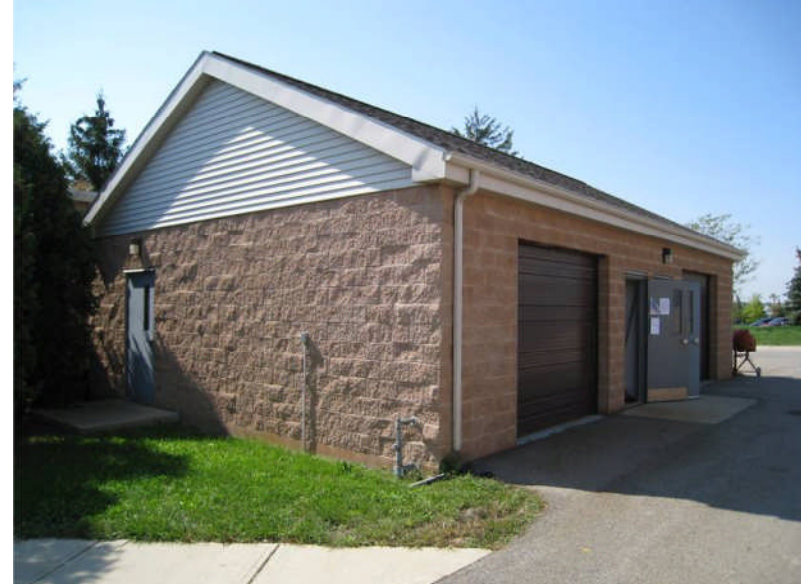
- Cracks in CMU exterior wall, primarily at the ends of steel lintels over the overhead sectional doors should be monitored.
- No reported roofing problems. Roof evaluation was not included in PSI's roofing condition report. No visual defects were noted.
- Gutters currently drain to immediate grade. Splash blocks should be installed to limit splash onto the building
- Doors and frames are protected with primer only. Doors and frames should be painted to protect them from moisture damage.

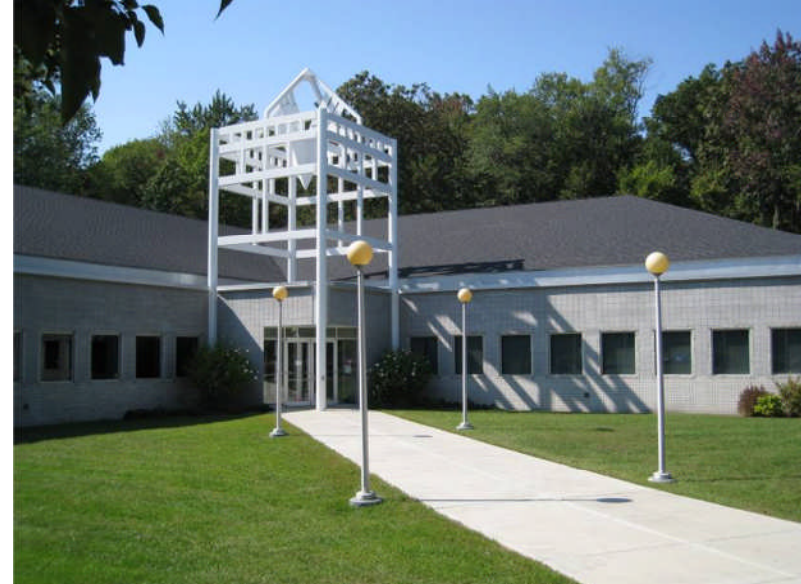
- Wireless equipment is at end of life and requires replacement.
- Corrections to cracking and moisture damage at Lobby were performed, recommend that condition is monitored. Isolation joints were installed to reduce the appearance of future cracking in some locations. This may prove to be a temporary correction.

- College has replaced fire alarm panel.
- Student Lounge Area exterior concrete slab joint material between sections needs replacing.
- Two gas-fired, forced draft, Weil-McLain heating hot water boilers (installed in 1991).

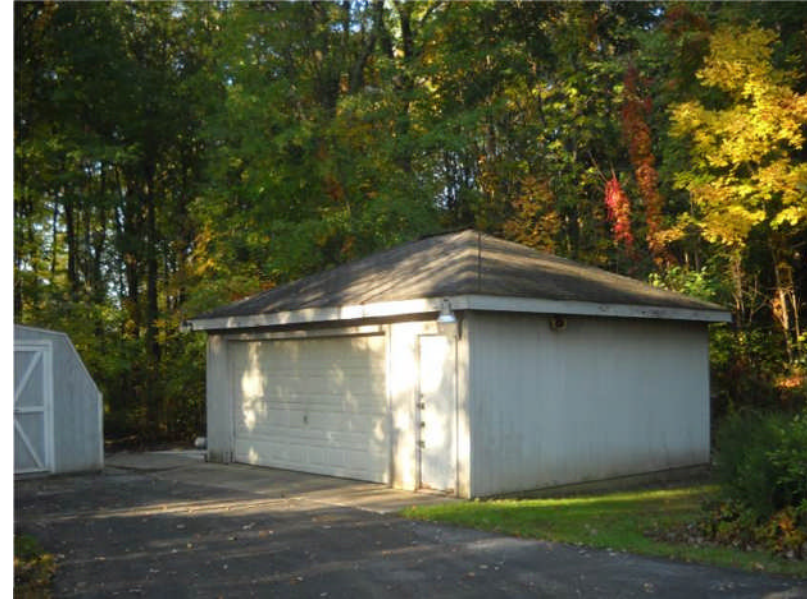
- Roofing was not replaced during the 2006 re-roof of the main building. Roofing is at end of life and due for replacement.
- Plywood siding is in good condition, needs repainting. Wood trim, in some areas, needs replacement. All wood trim needs repainting.
- Overhead sectional door and man door are at end of life and due for replacement.

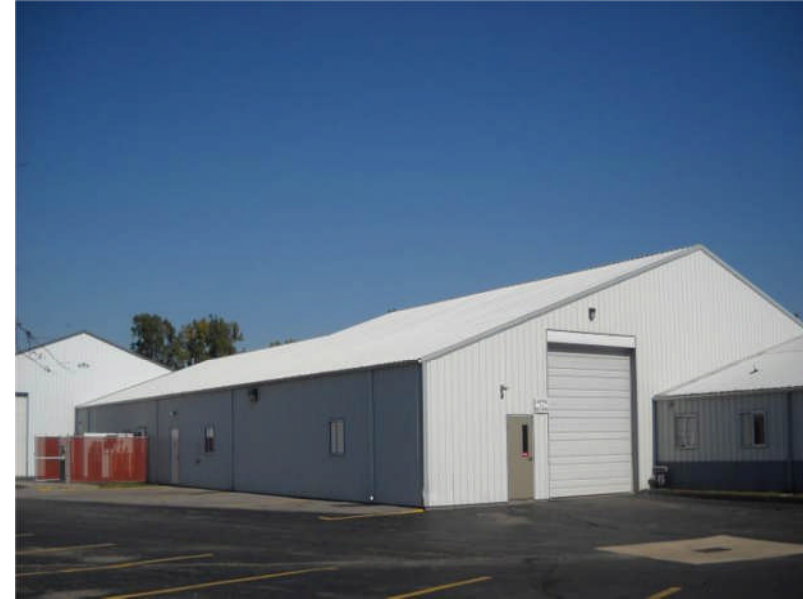
- Man door at southern end is prime-coated, needs painting.
- Toilet room is not ADA compliant.
- Rafter-hung, gas-fired heater is vented through roof.
