# Building Report | CLRC Renovations and Additions Project

10.22.21

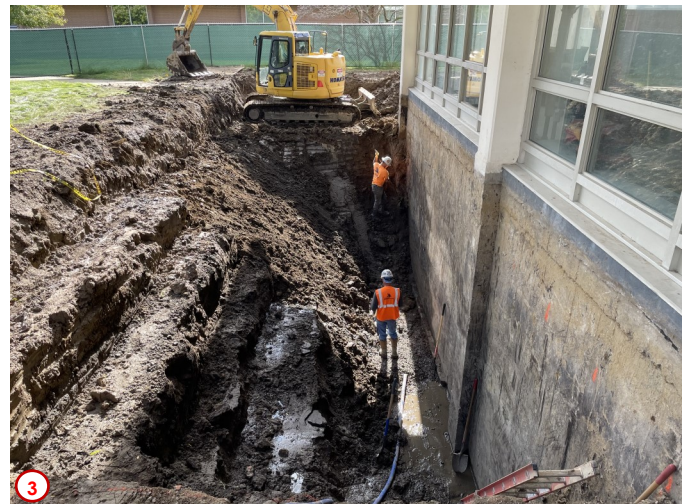
Photo #3 highlights the progress of the excavation on the east side of the building in the effort to expose the basement wall. This area is outside of the Little Theater and Classroom C-17. The basement wall will be scraped clean and then power washed. After that an adhesive will be applied which will help the new drainboard remain adhered to the wall. Finally, before backfilling a drain tile will be installed that will help convey storm and groundwater over to the storm sewer basin located near the southwest corner of the building. Then eventually the water ends up metering out into Plum Creek on the south end of campus.

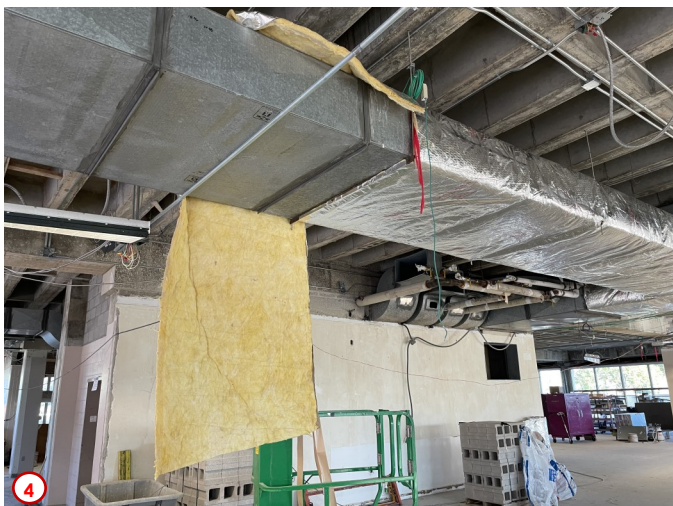
Photo #4 shows more of the existing mechanical ductwork being insulated. The insulators have nearly finished insulating existing mechanical infrastructure on the second floor, and now are starting on the first floor. Again this will help existing mechanical systems to be brought up to current energy codes which in the end will make them more efficient.

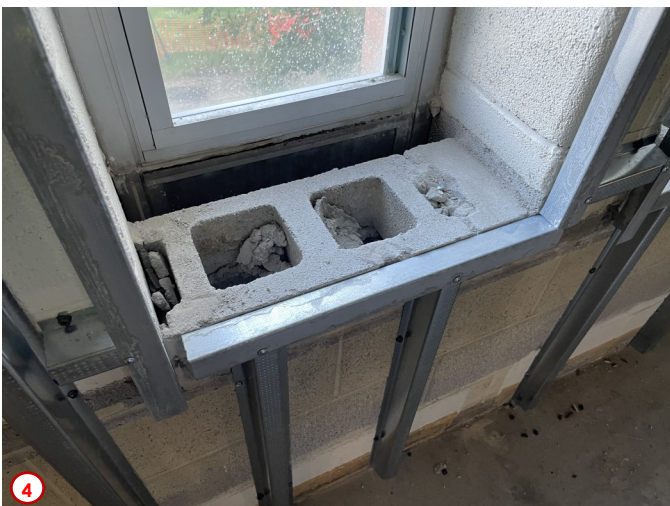
Photo #4 is a detailed view of a typical situation that is happening at all of the existing windows on the second floor. There metal framing has been installed that will allow wallboard to be installed around the existing opening. Then over the existing concrete block a new cultured marble window will be installed after the new windows are in place.
