# Building Report | CLRC Renovations and Additions Project

11.12.21

The following are pictures from the week ending in 11.12.21 in regards to the CLRC Renovations and Additions Project. There was a lot of activity this week as the targeted waterproofing for the basement began, new framing for some of the walls on the first floor was installed, and more of the in-wall infrastructure was finished on the second floor. There will be a concentrated effort to finish the waterproofing around the south face of the basement so that it can be backfilled so that the foundation system for the addition at the south-east corner of the building can be installed along with the pads for the existing condensers for the server room A/C units can be relocated to their new locations. A lot of coordination is happening with the architects, engineers, and college representatives as we all collaborate on finalizing numerous items such as furniture, security camera and access control locations, the library patron counting system, A/V integration throughout the building, etc. All of these need to be set prior to finishes being installed.

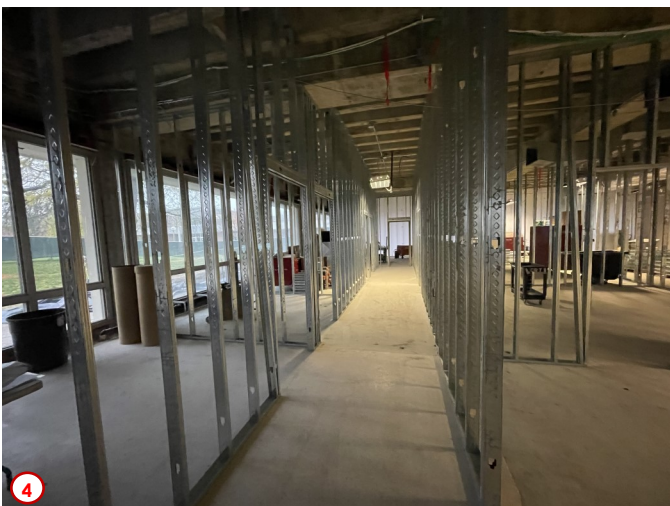
Photo #4 is a view down the future corridor in the Library Office Suite on the first floor. This secure office suite will house offices, a workroom, and a staff lounge.

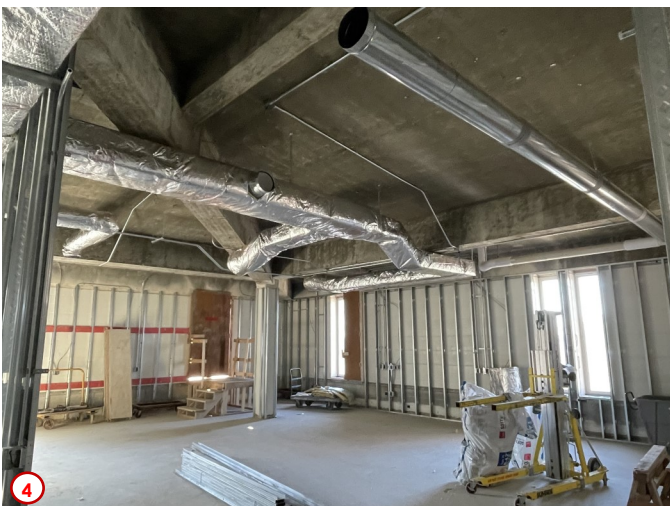
Photo #4 highlights the progress of the installation of the mechanical infrastructure in the area that will be the Student Publications Room. You can see the new ductwork already being insulated so as to meet the energy efficiency requirements of the latest building code guidelines.
