# Building Report | CLRC Renovations and Additions Project

## 11.5.21

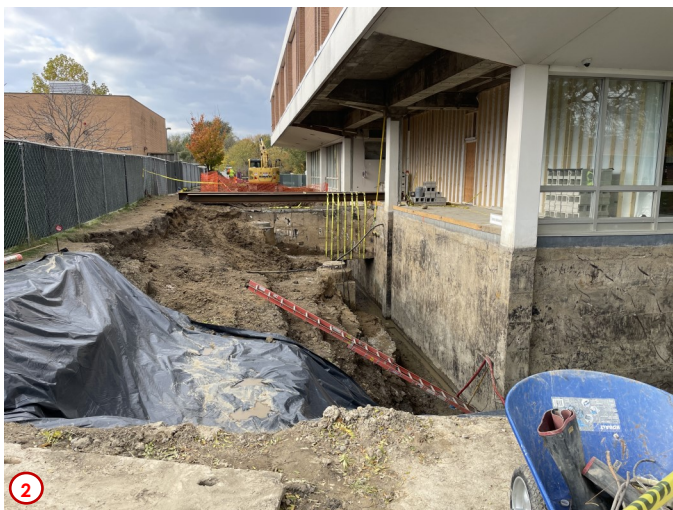
Photo #2 was taken after excavation was completed around the steam tunnel. Digging will continue up to the existing overhead door and then the exposed walls will be waterproofed. Then once they are backfilled the excavation for the remaining portion will happen. Then the already completed area will be prepped for the foundation system installation for the addition happening at the southeast corner of the building.

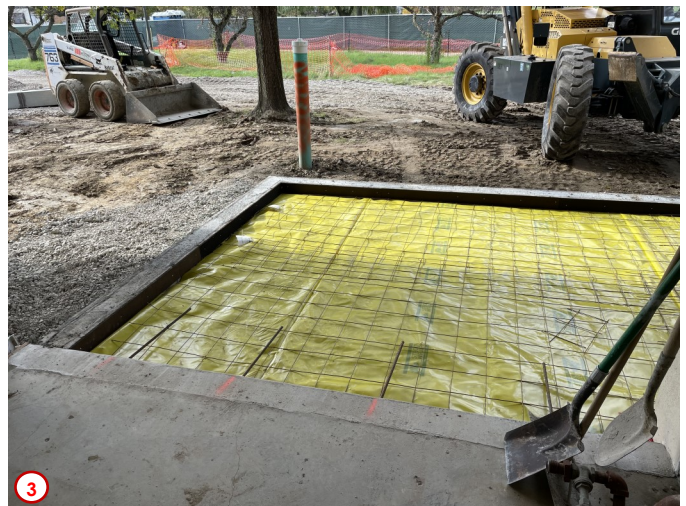
Photo #3 was taken later in the week after Photo #'s 1 and 2. Here you can see the vapor barrier has been installed over the compacted fill along with the wire reinforcing mesh. You can also see the dowel rods which will help provide stability between the new and existing slabs and help to create a uniform floor slab.
