# Building Report | CLRC Renovations and Additions Project

## 03.11.22

The following are pictures from the week ending in 03.11.22 in regards to the CLRC Renovations and Additions Project. Another major milestone was reached this week with this project, and that is the completion of the new curtain wall system with not only the replacement sections but the new as well around the additions. This means the exterior of the building is now weather-proofed which will greatly aid in the efforts to finish the interior of the first floor. Also happening this past week as the flush test for the fire sprinkler system at the new fire department connection. The test was successful and received approval by the local fire marshal. This means the new fire riser can be constructed as the contractors push towards wrapping up that portion of the project. In the next few weeks will see the roofing contractors arrive on site so that they can begin the process of replacing the existing built-up roof with a new hybrid system. Additionally more site work will commence in the few weeks as the site work on the east side of the building will get underway.

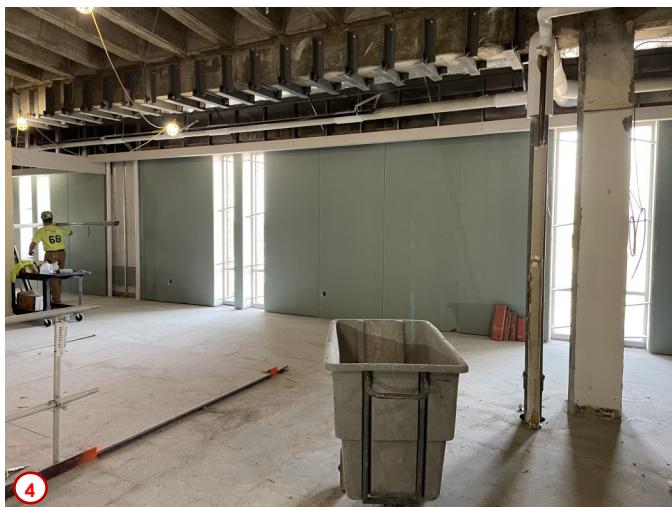
Photo #4 shows the Commons Area at the top of the western stair tower on the second floor and the last few sheets of wallboard being installed over the new framing and furring. Also happening in this area immediately around the perimeter of the stairs will be the framing for enclosure for the fire shutters.
