Building Report | CLRC Renovations and Additions Project

8.6.21

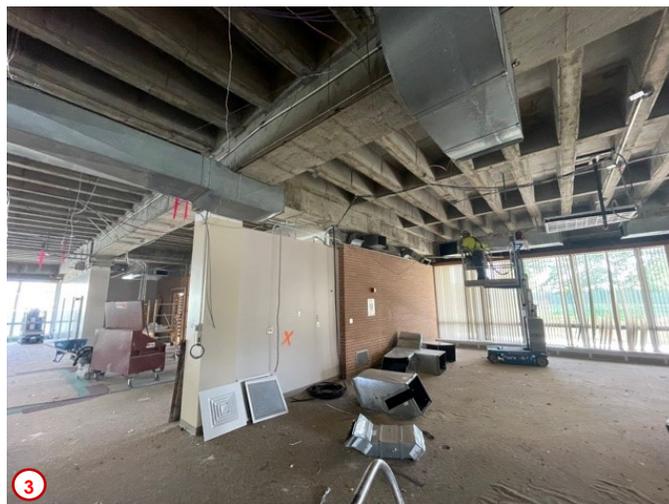
Photo #3 show more of the progress in the old Library space. In this photo one can see that the old HVAC ductwork supplying this area is being removed. Soon the remainder of the walls and floor finishes in this portion of the building will be removed as well to permit the contractors to erect the framing per the proposed layout. This particular area will be the location of the new office suite and partially the entrance gallery into the library.
