# Building Report | CLRC Renovations and Additions Project

9.10.21

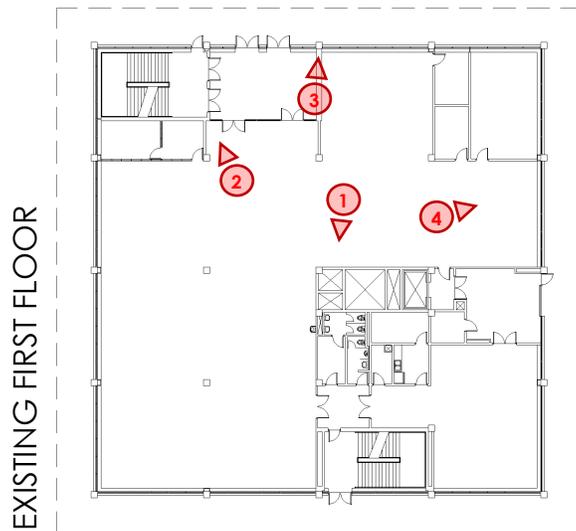
Photo #1 shows the progress of the removal of the mastic that was used to adhere the carpeting once in the Library to the floor slab. It was necessary to remove this to allow for the new wall framing, and so the new flooring to be installed in this area will be properly adhered to the slab and warranted by the manufacturer.

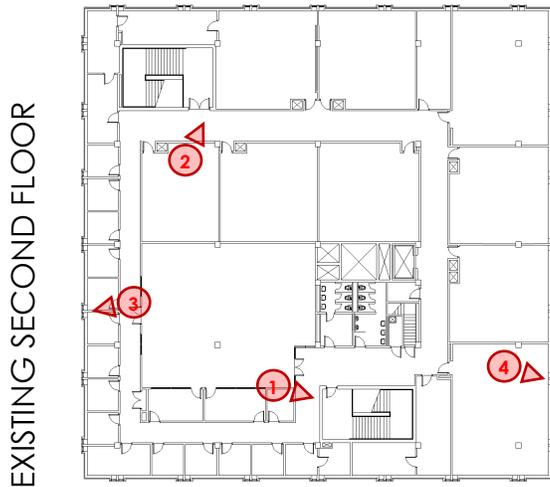
Photo #1 shows the progress of the start of the last major demolition work in the CLRC, and that is the removal of 3 of the 4 walls of the west stair on the first and second floors. These walls will be replaced by a retractable fire curtain that will deploy in case of a fire emergency. The removal of these walls will allow the creation of the open floor plan that was desired and to aid the infiltration of more natural light into the building interior.
