MONROE COUNTY
COMMUNITY COLLEGE

October | 2015

5 YEAR

Master Plan

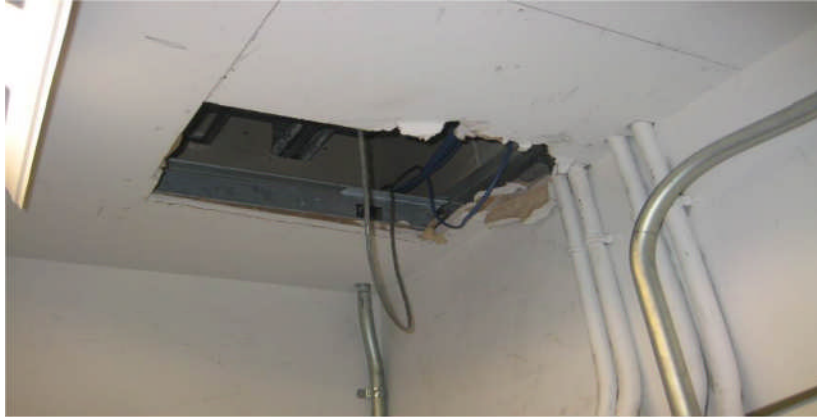
Whitman Center – breach in fire-rated ceiling assembly.

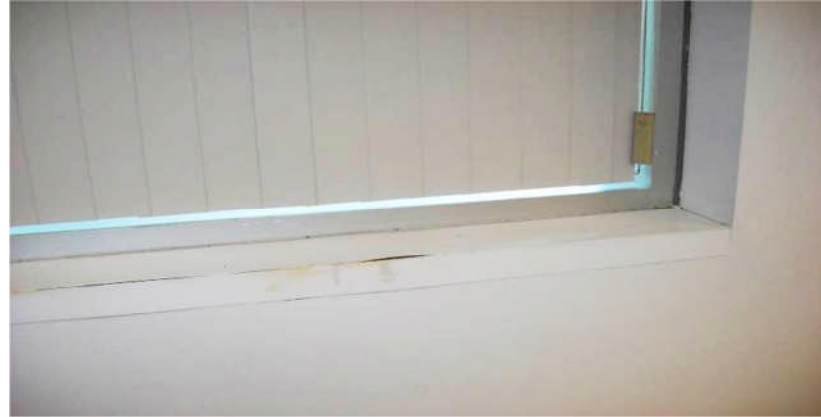
Whitman Center – water infiltration along exterior wall has caused deterioration of the plastic-laminated windowsills.

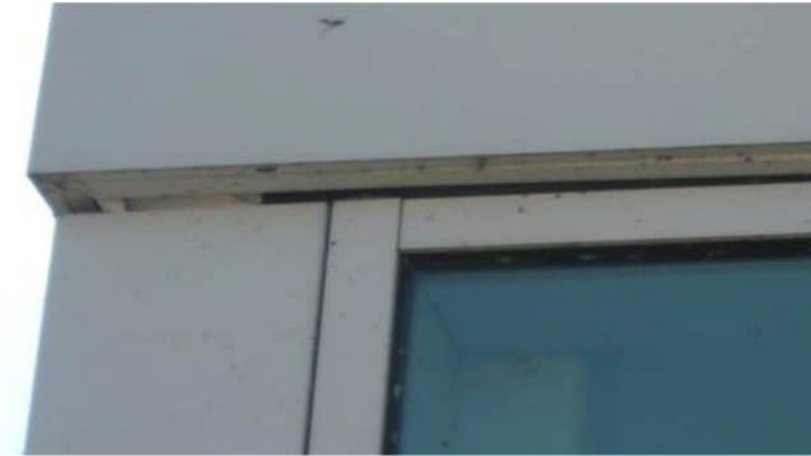
La-Z-Boy Center – It appears there is a void within the exterior aluminum, curtain wall assembly allowing the environment to enter the interior.

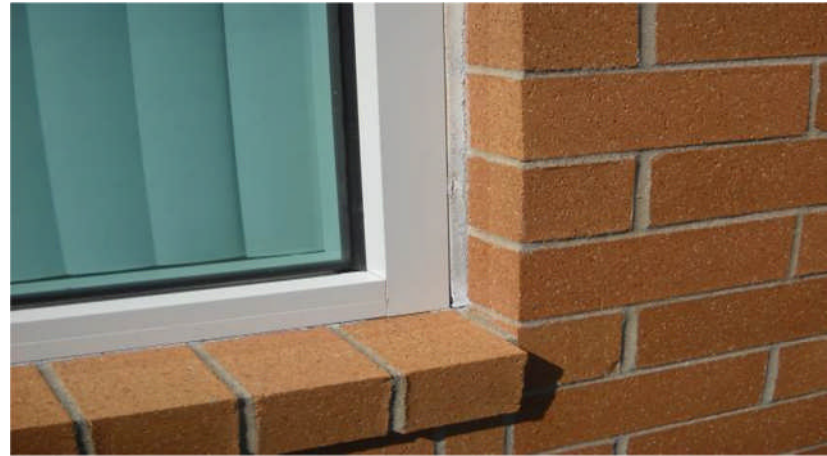
Health Education Building – Typical sealant joint is at end of life.

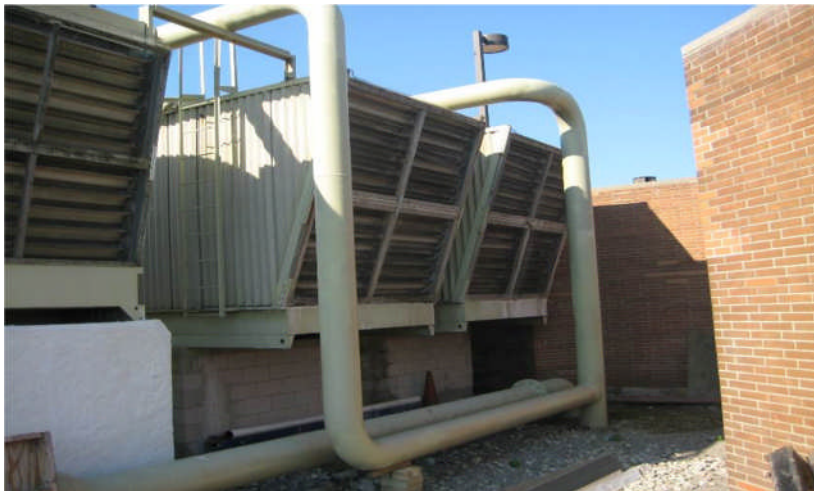
Physical Plant – Cooling tower and basins are near end of life.

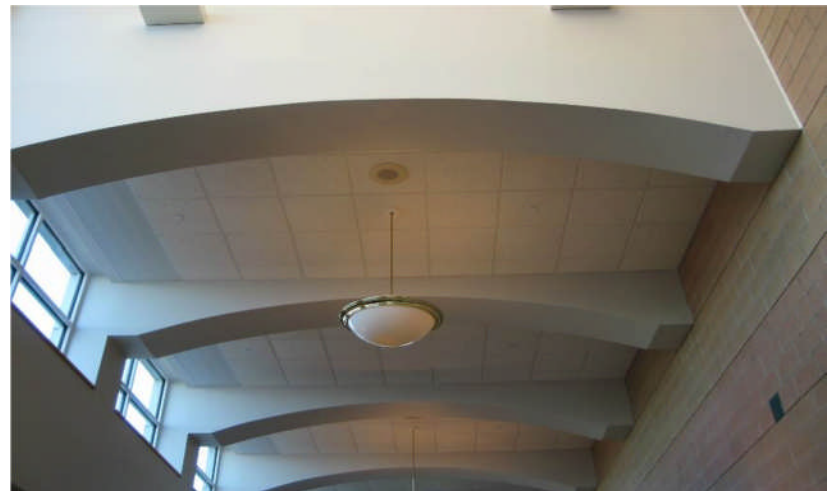
Health Education Building – Daylighting controls for the Atrium would save energy.

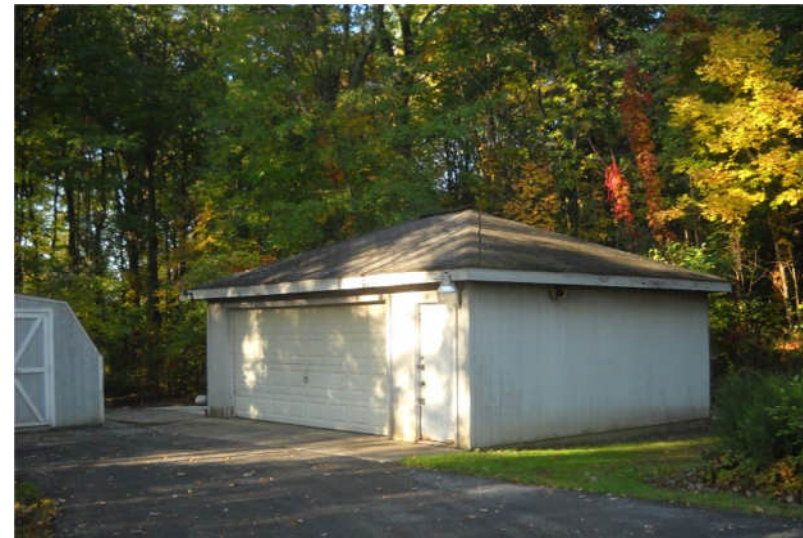
- Roofing was not replaced during the 2006 re-roof of the main building. Roofing is at end of life and due for replacement.
- Plywood siding is in good condition, needs repainting. Wood trim, in some areas, needs replacement. All wood trim needs repainting.
- Overhead sectional door and man door are at end of life and due for replacement.

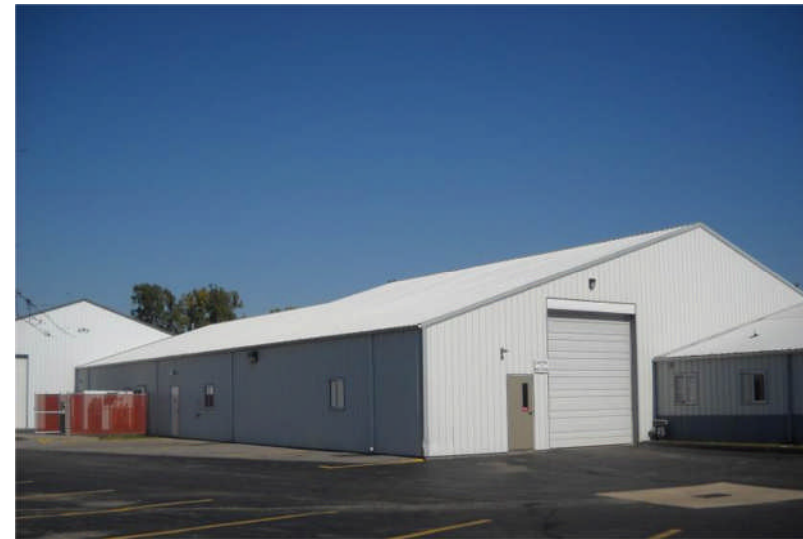
- Man door at southern end of building is prime-coated, needs painting.
- Toilet room is not ADA compliant.

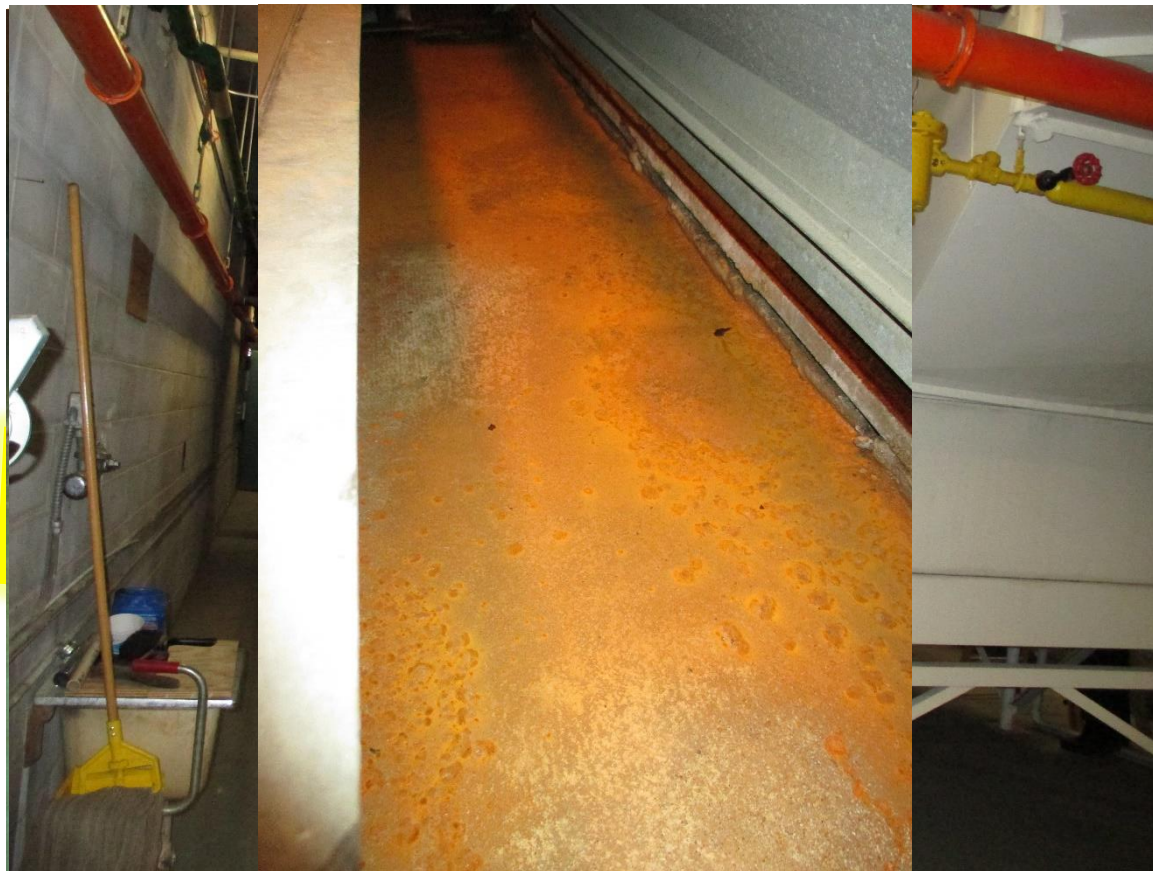
WHY THE NEED FOR NEW HVAC SYSTEMS?

- Failing equipment

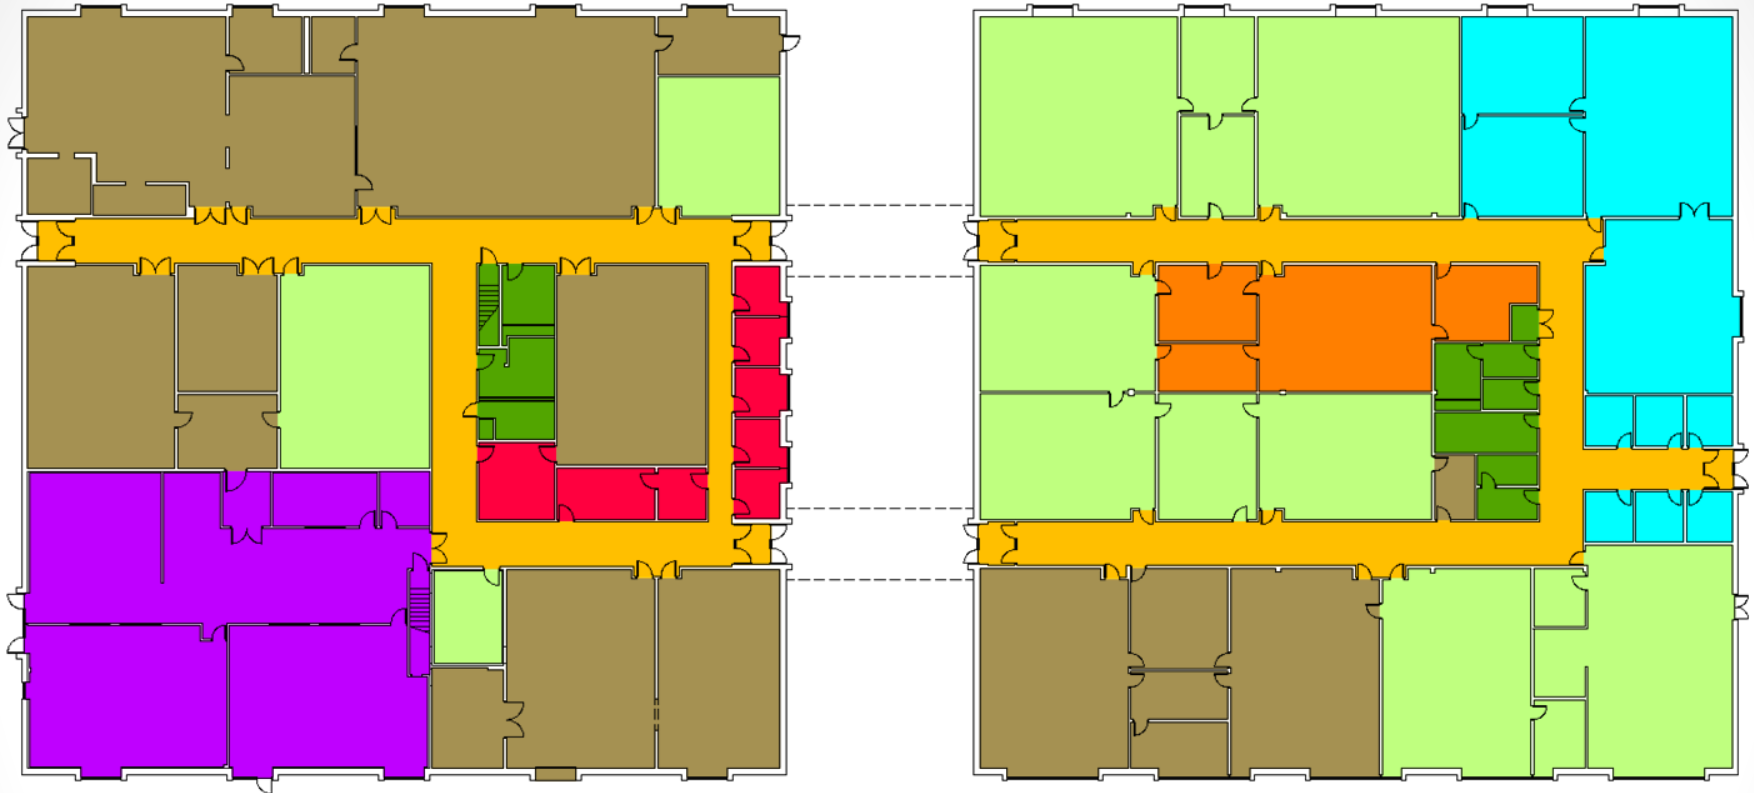
EXISTING FLOOR PLANS

Building Areas: East Tech = 23,117 sf | West Tech = 23,108 sf

Classrooms and laboratories in the East Technology Building and the West Technology Building are currently offline as they need to be renovated before they can be usable instructional space.

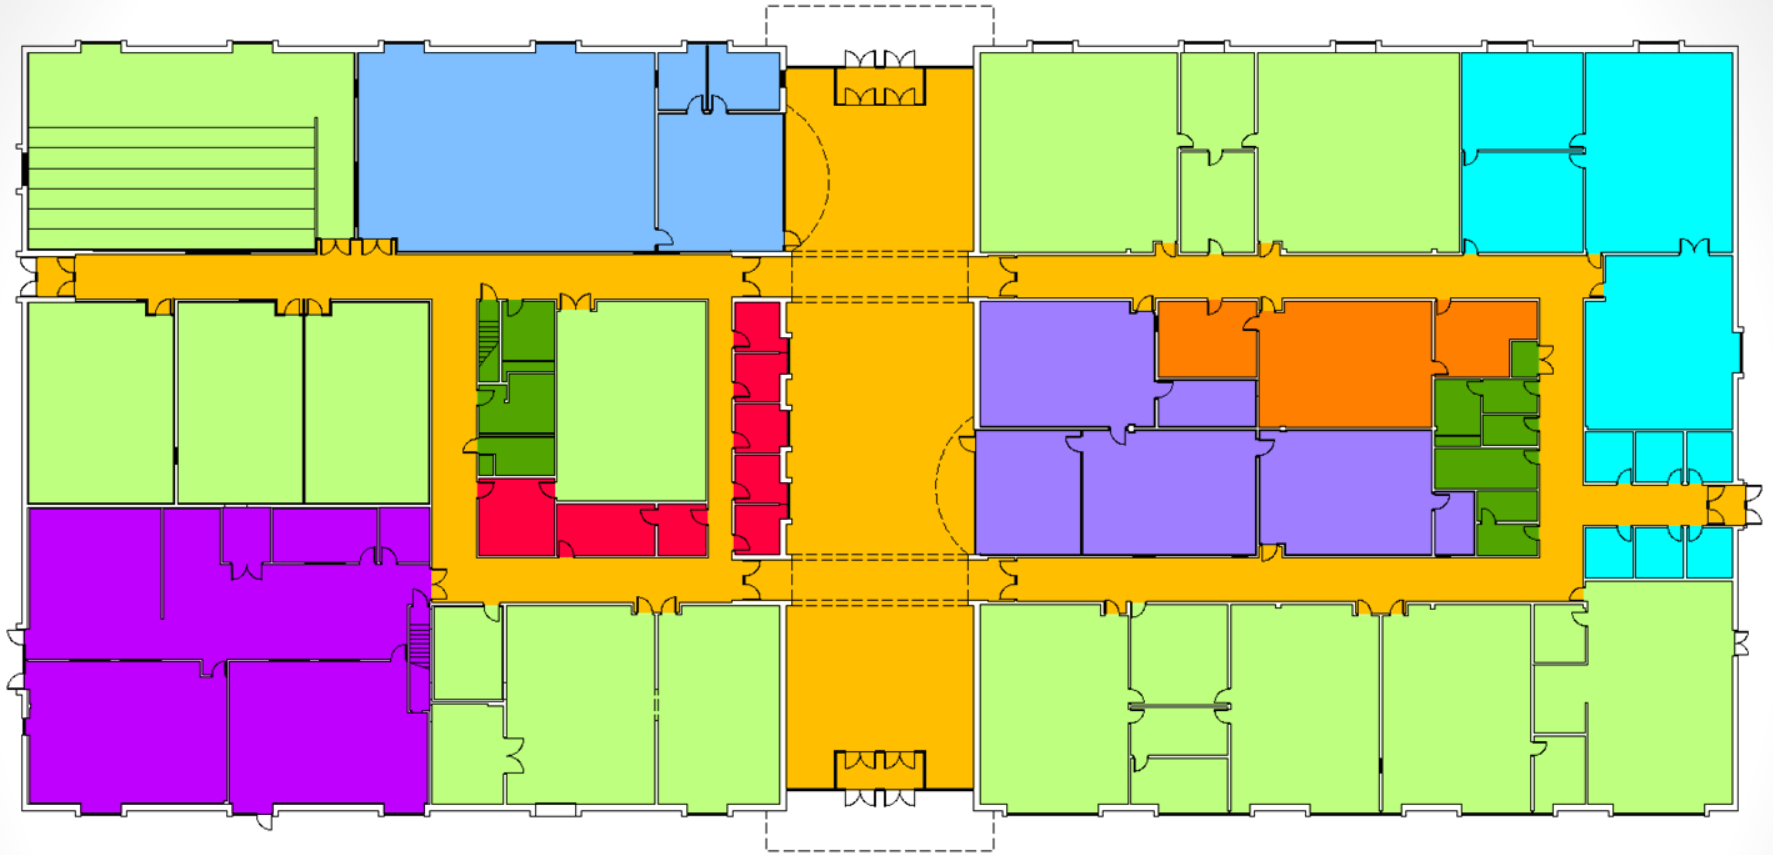
PROPOSED FLOOR PLAN

Building Areas : Existing = 46,225 sf | New = 5,245 sf | Total = 51,470 sf
