Building Report | E/W Tech Renovations & Addition

7.12.19

The following are pictures from week of 6.24.19 - 7.12.19 in regards to the East/West Technology Buildings Renovations and Addition Project. With the Independence Day holiday break I decided to combine the last few weeks of reports together as construction slowed slightly during that time period. Activity has picked back up with the grade beams for the foundation being installed as well as many infrastructure items such as new thickened slabs, HVAC ductwork, and the beginnings of the new building-wide fire sprinkler system. Some of the steel for the new addition has been shipped and is ready for installation. There is also some underground infrastructure updates happening in regards to both the sanitary and storm water systems. The electrical contractor is working on relocating all of the old panels from the corridors to their new rooms in both wings of the building. For future reference I have switched out the reference floor plans shown below from old to new as demo ends and new construction is the focus of the contractors.

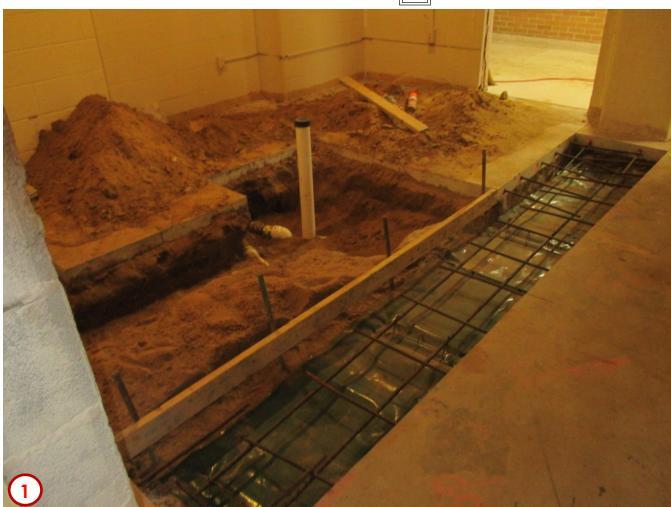
Photo #1 shows the area that will be the new unisex restroom in the western half of the building. Here you can see the existing floor slab cut open for new plumbing and a thickened slab that will support the new masonry wall that will be constructed soon. Photo #2 shows the first of the grade beams as part of the foundation system at the north end of the building addition. Photo #3 shows the contractors installing the formwork and reinforcing steel cages so the concrete can be placed for the grade beams for the center section for the building addition. We are on track for the foundations to be completed so that the structural steel for the addition can start going up around the end of July.

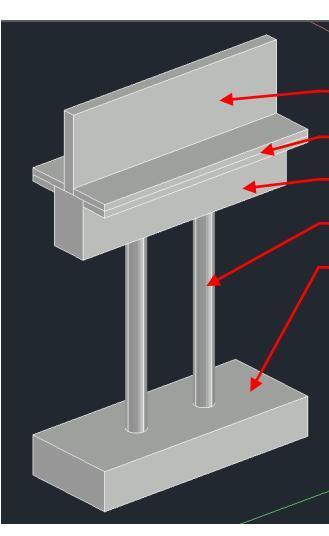
I created this diagram to better illustrate the foundation system for the new addition.

- New masonry wall.
- -New floor slab with stone base
- New grade beam
- New caisson
- Existing bedrock

Note: not shown is the existing soils that would surround the caissons, above the bedrock, and below the floor slab. This system is used when the existing soils cannot support the weight of the new structure which is the situation we have in this area of campus.
