Building Report | Life Sciences Façade & Addition

9.22.17

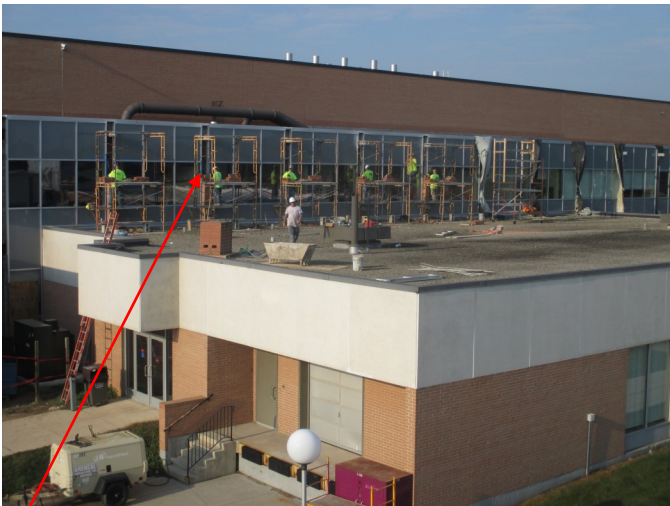
The top-left photo shows the masons constructing the new brick ribs above the north classrooms. Once the brick ribs are completed a partial roof replacement will be completed as part of the project.

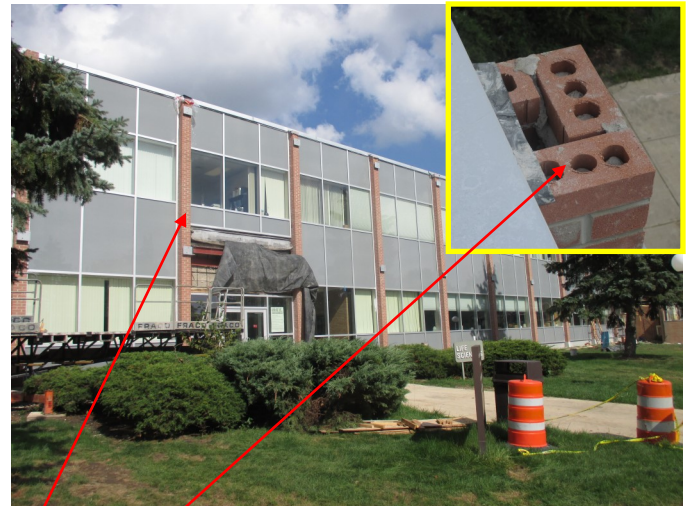
The top-right photo shows the south façade of the Life Sciences where all but two of the new brick ribs finished. The enlarged photo in the corner shows the top of one of the brick ribs. The tops of the brick ribs will be covered in flashing to match the existing to help keep water and debris out of the cavity.

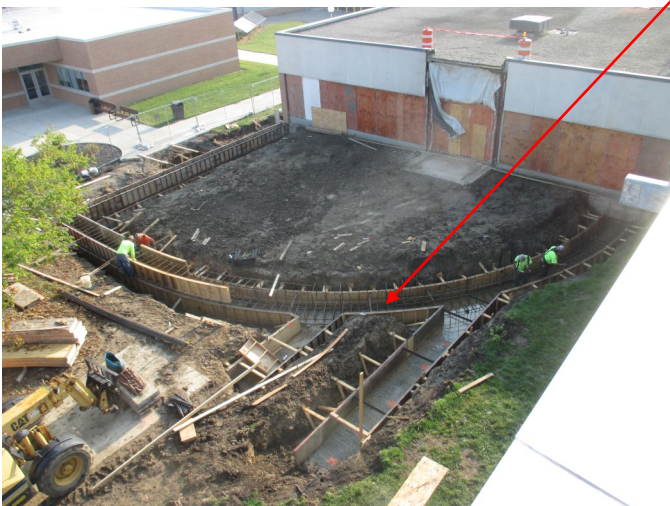
The bottom-left photo shows the completion of the formwork for the foundation for the addition which will be poured next week.

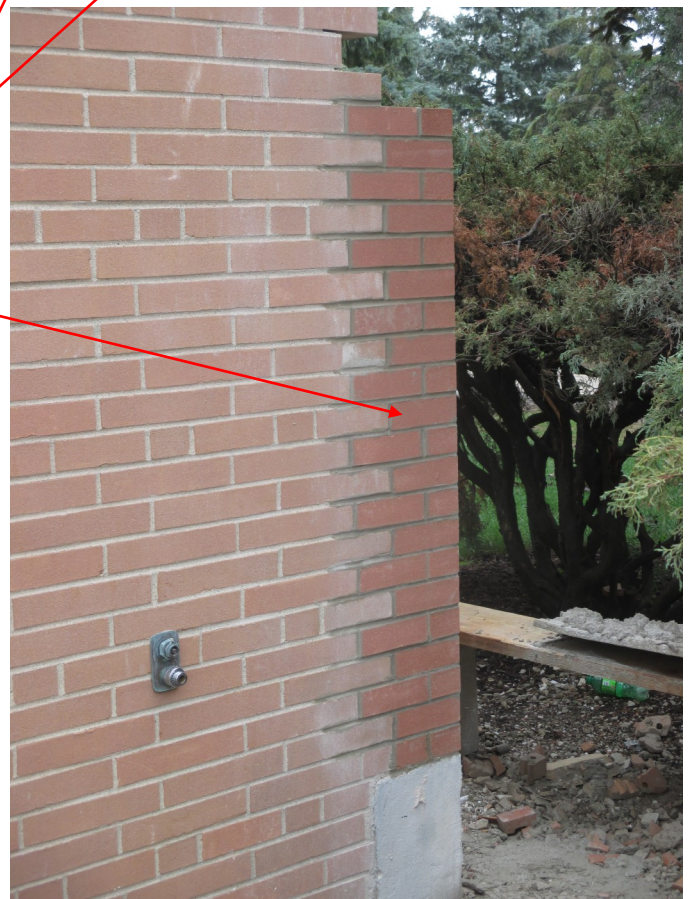
The bottom-right photo shows the southwest corner rib and it's reconstruction. Here new brick is being "toothed in" because this rib is an extension of part of the west wall of the building. This process takes longer and is more difficult where the other ribs are easier because they are completely new installations.
