Monroe County Community College

5-Year Master Plan

September 2022

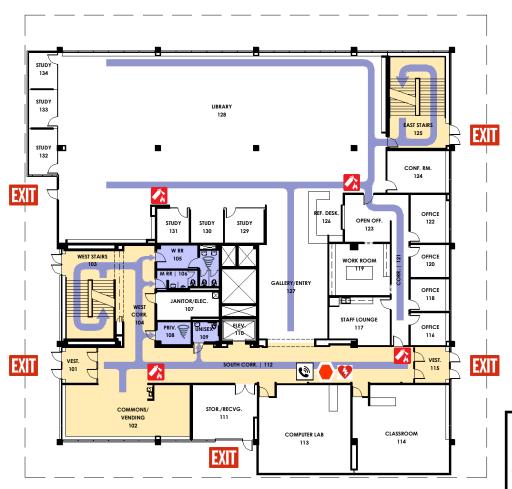
Emergency Plan | 1st Floor

Note: Please proceed to the lower level for the designated tornado shelters.

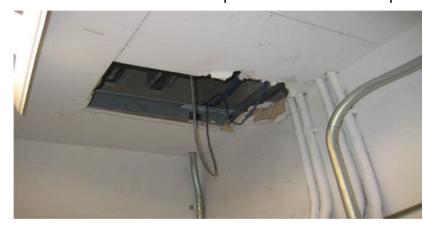
Whitman Center - breach in fire-rated ceiling assembly.

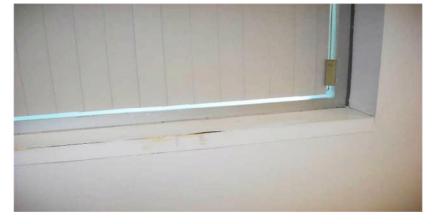
Whitman Center – water infiltration along exterior wall has caused deterioration of the plastic-laminated windowsills.

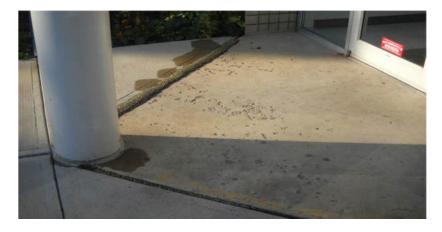
Whitman Center – settlement/heaving of exterior concrete slab (at main entrance) presents a tripping hazard.

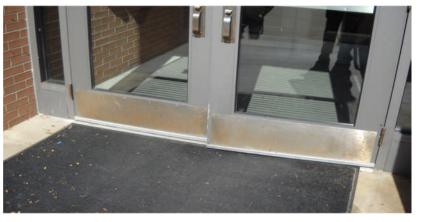
Student Services/Administration - Aluminum entrance doors and hardware at end of life.

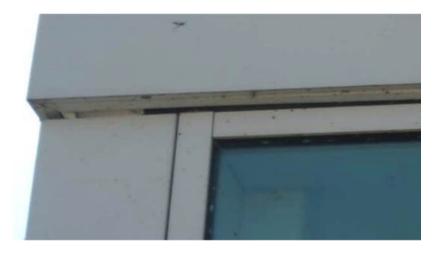
La-Z-Boy Center – It appears there is a void within the exterior aluminum, curtain wall assembly allowing the environment to enter the interior.

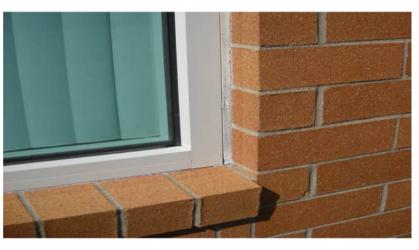
Health Education Building – Typical sealant joint is at end of life.

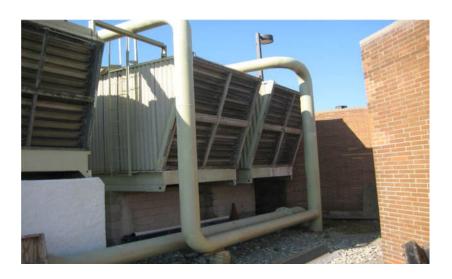
Physical Plant – Cooling tower and basins are near end of life.

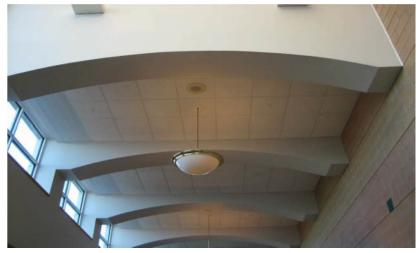
Health Education Building – Daylighting controls for the Atrium would save energy.
