# Building Report | Annual Sidewalk Maintenance

8.23.19

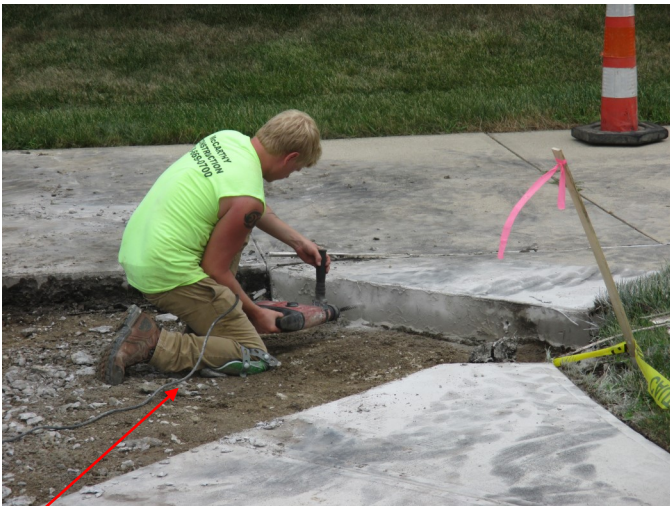
The top-left photo an area of walk in the central portion of the campus mall has been removed and the contractor is drilling holes for the metal pins that will connect the concrete to the existing.

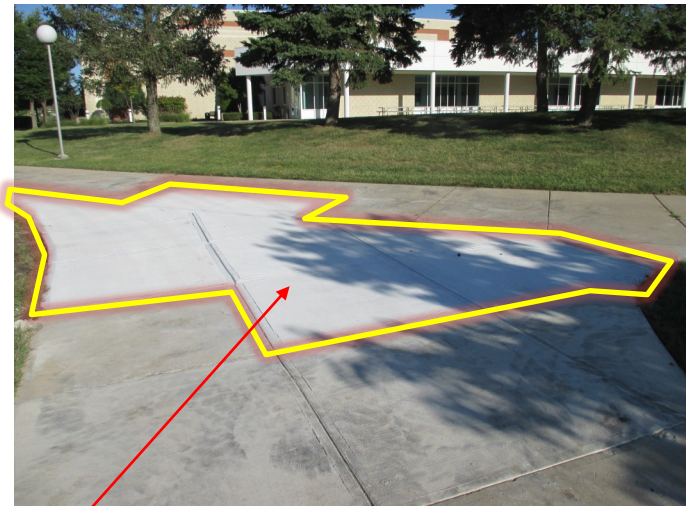
The top-right photo is of the same are, but shows the finished concrete in place. Each of the new flags (or portions) of walk have been sealed to help out with longevity.

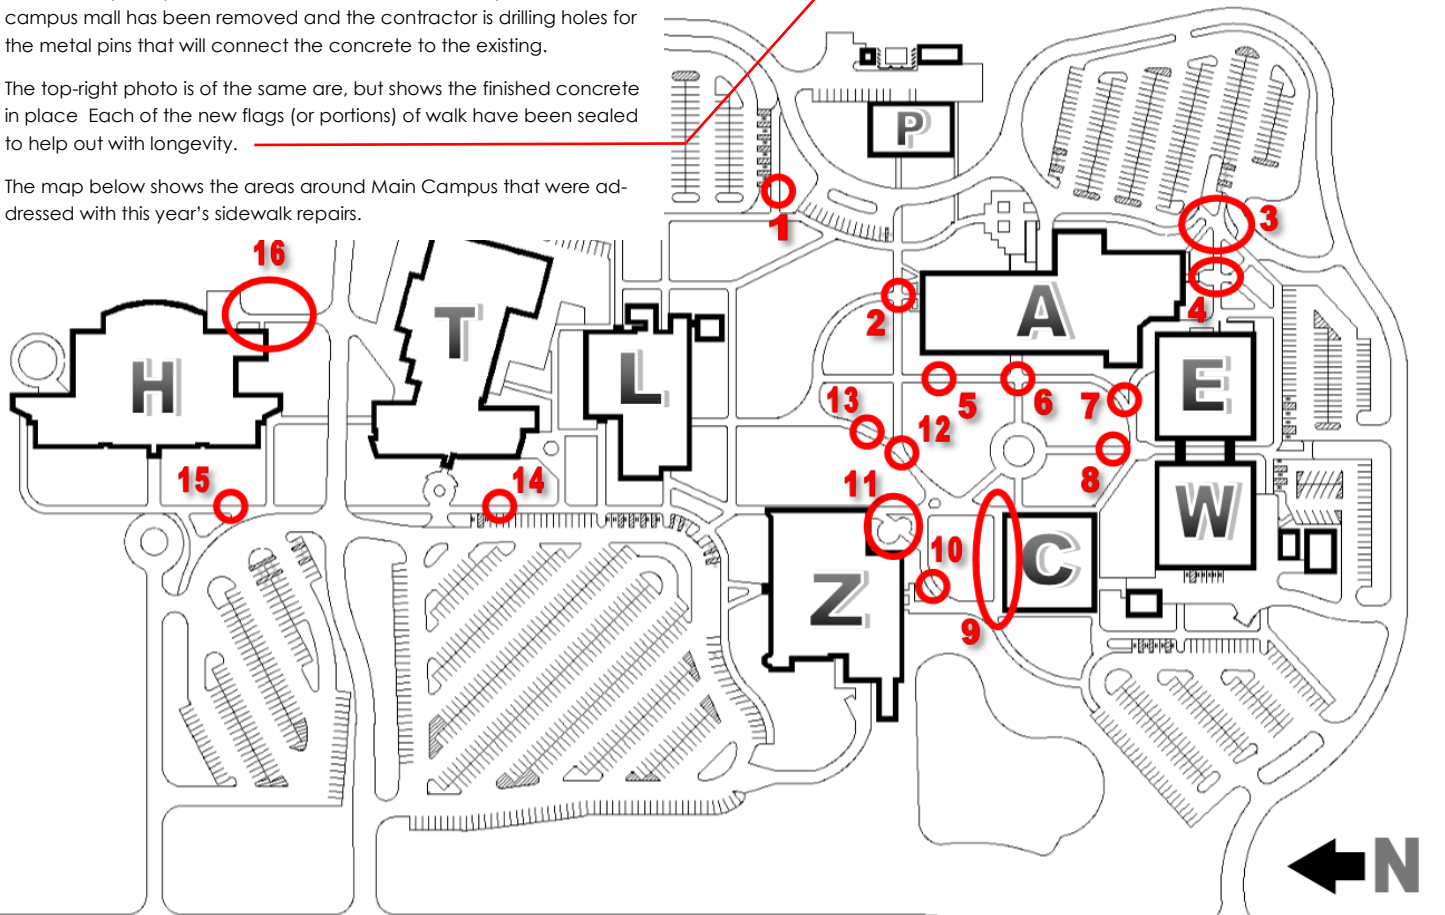
The map below shows the areas around Main Campus that were addressed with this year's sidewalk repairs.
