Building Report | Life Sciences Façade & Addition

11.3.17

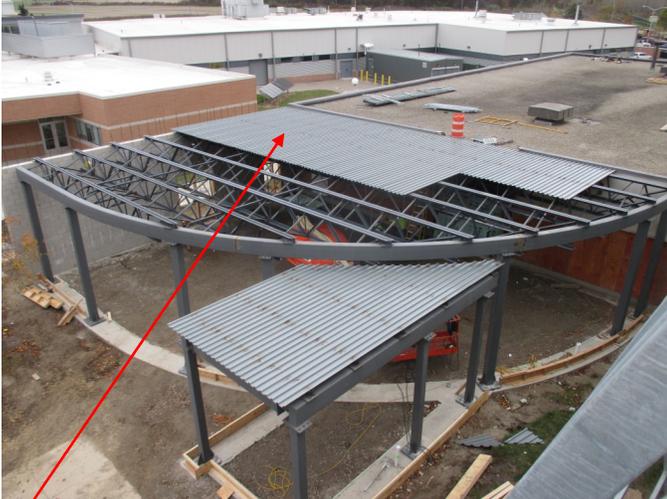
The top-left photo shows the progress of the installation of the metal decking for the addition roof. Once completed a thin layer of concrete will be placed on top to help create rigidity in the addition.

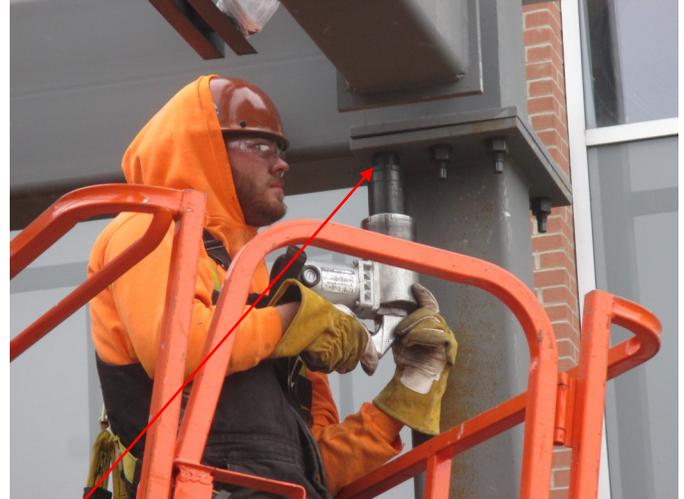
The top-right photo shows one of the ironworkers tightening all of the bolts in the steel framing. The bolts were tightened after all of support steel was in place along with the roof bar joists.

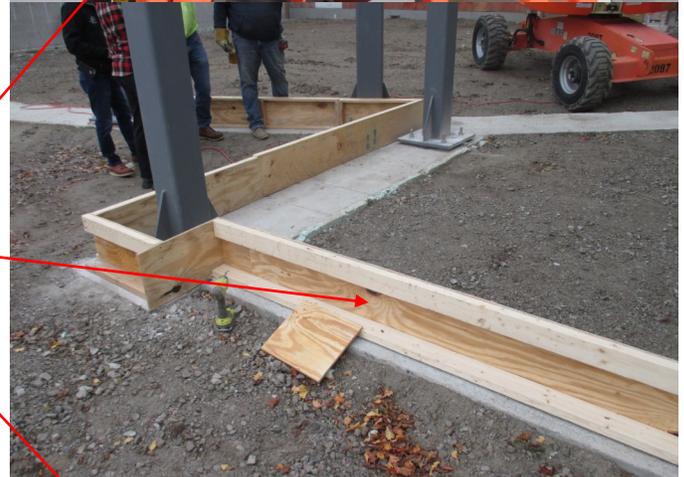
The middle-right photo shows some of the wood forms being constructed prior to the placement of the concrete floor slab for the addition.

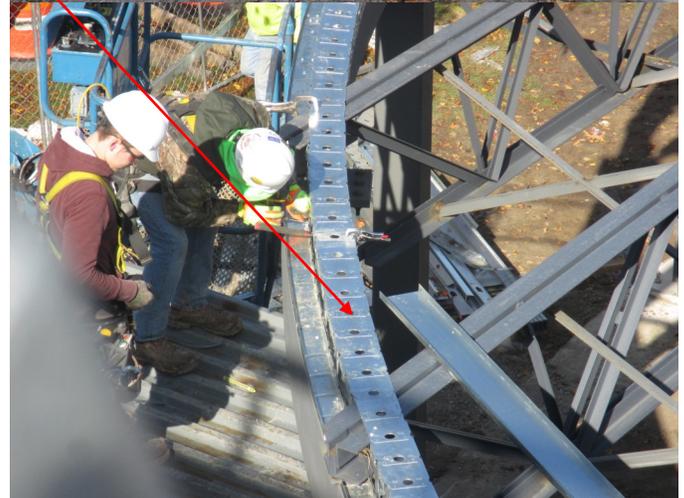
The bottom-right photo highlights the installation of the flexible metal track that the framing will connect that will become part of the parapet wall on the curved face of the addition façade.

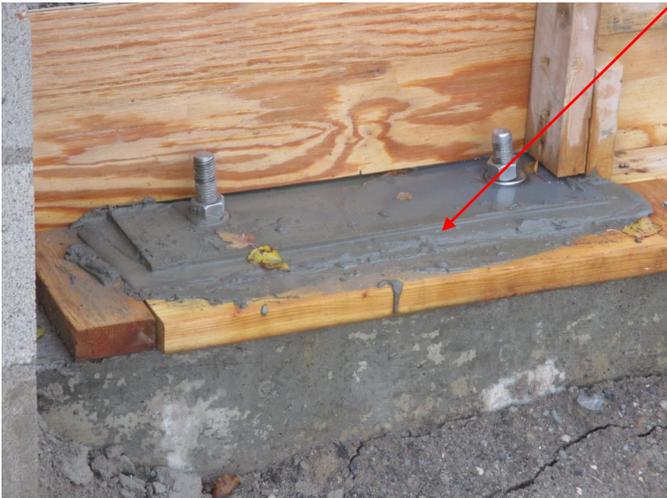
The bottom-left photo shows the non-shrink grout has been placed between the bottom plate of the steel column and the top of the concrete footing. This grout had to be installed prior to the placement of the concrete floor slab.
